Report: 501 w. alabama ave, ruston 01-09-2020

Confidential Inspection Report

501 W. Alabama Ave

Ruston, la

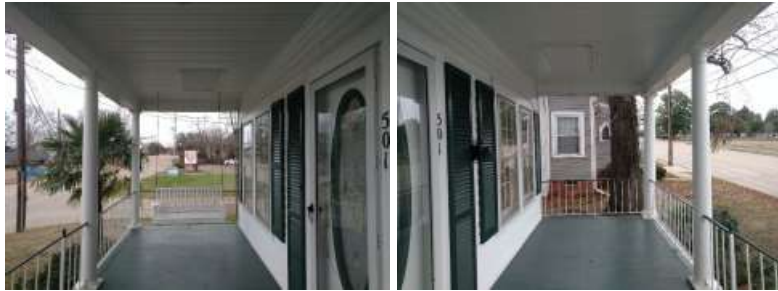
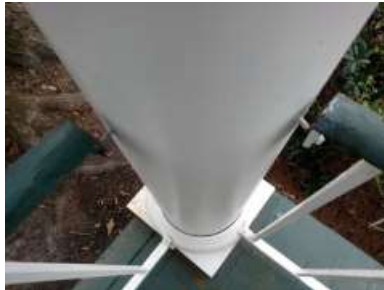
Structure:

Type: Same as structure, With wood columns.
 Some hand rail fasteners loose.

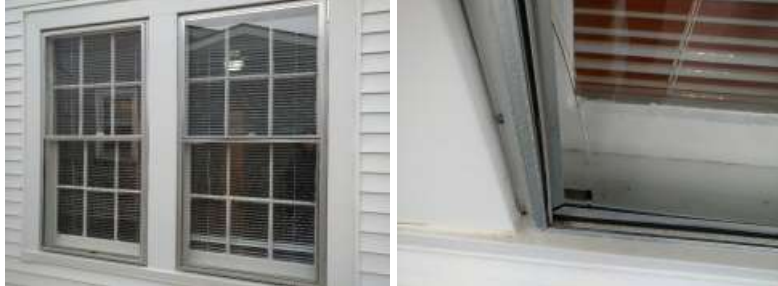
Overall Condition:

Satisfactory overall, considering age.
 Cracked storm window front side of house.

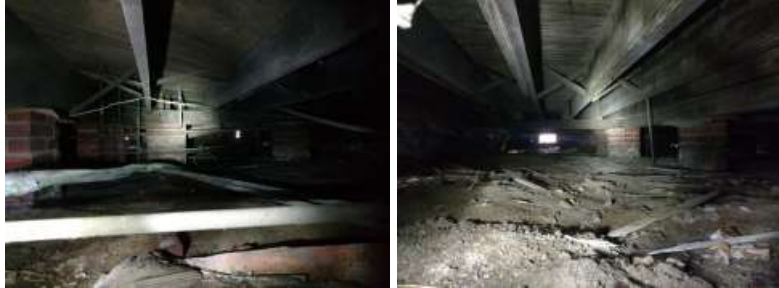
Crawlspace:

- Access: Viewed from vent ports. Not crawled due to height restrictions and sewer leak.
- Walls: OK MM RR Wall materials are brick.
- Moisture: OK MM RR Moisture under kitchen at damaged drain line area.
- Beams/Underfloor: OK MM RR Limited view. General condition appears serviceable.

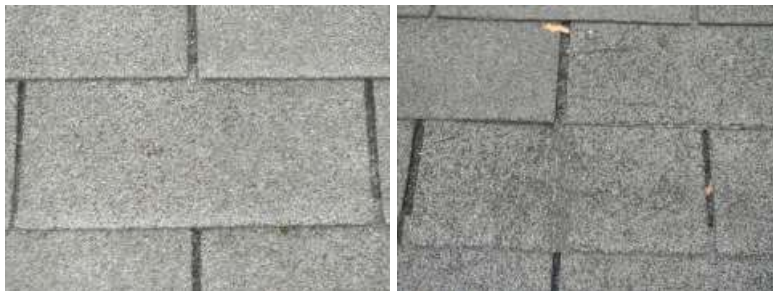
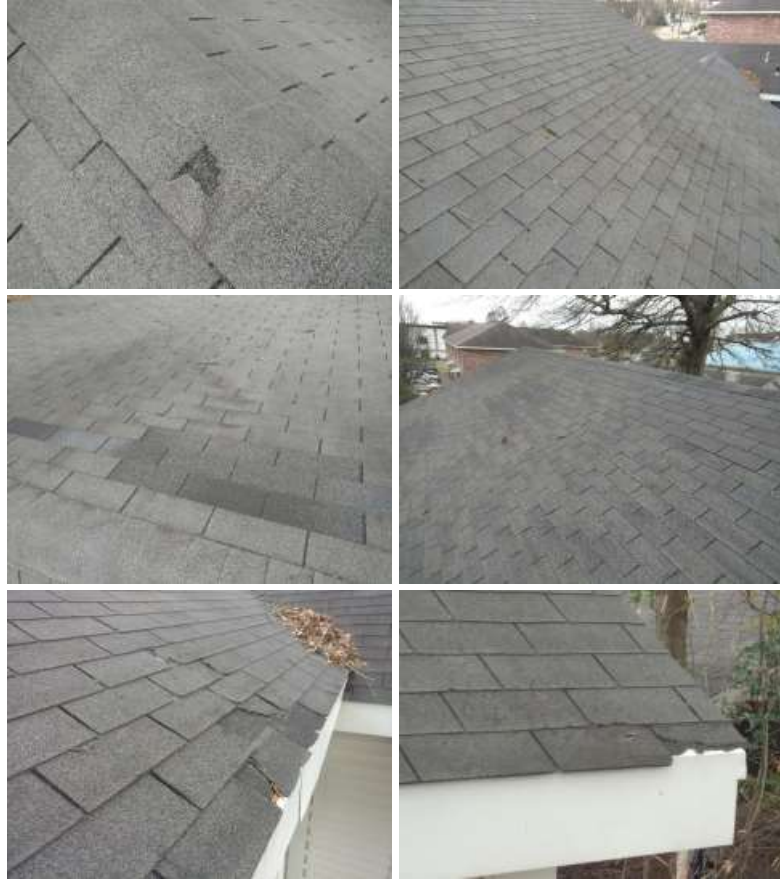
Roof Covering Condition:
 Recommend further evaluation by a licensed competent roofing contractor due to heavy wear and damaged shingles.
 heavy wear and tear noted.
 moss growth noted.
 Patch noted front side of house.
 Multiple patches noted left side of house.
 Damaged shingles rear patio. Decking visible, area of deterioration noted.
 Damaged shingles noted at garage.

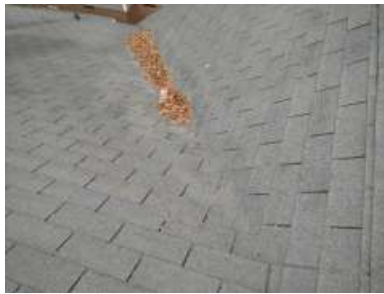
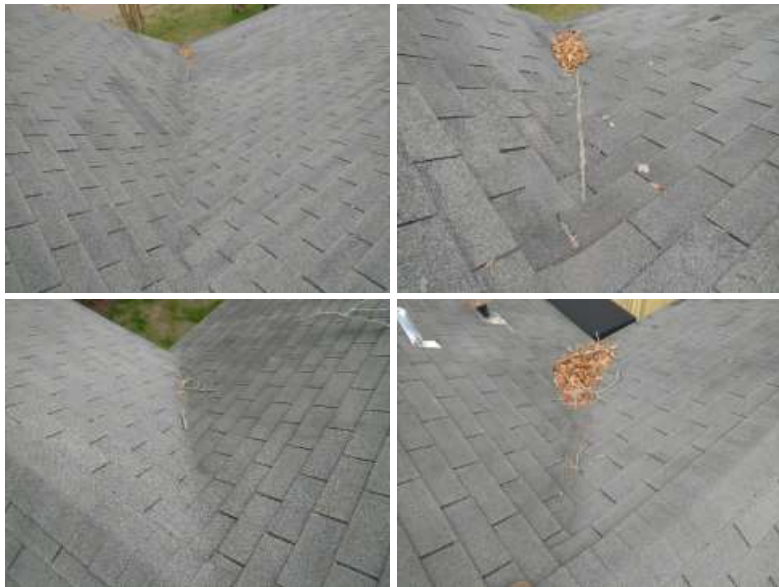
Valleys:

Caulking noted in valley left side of house.

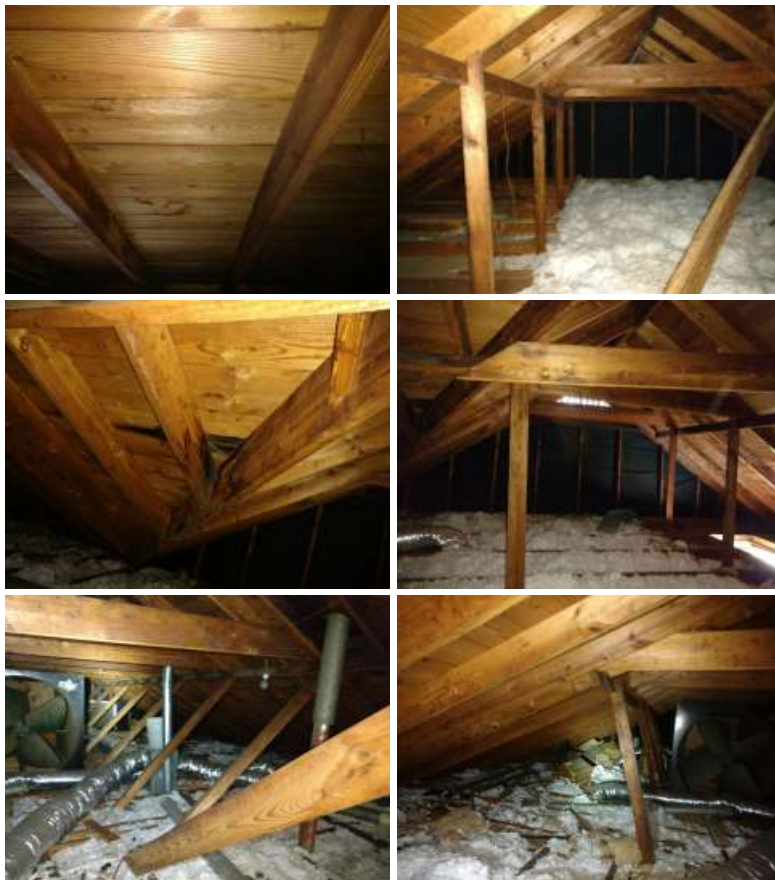
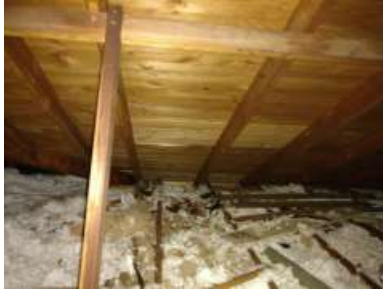
Structure: SHEATHING- The decking is made of butted one inch nominal boards, Some patch work noted.
 A rafter system is installed in the attic cavity to support the roof decking.
 Some stains noted on decking.

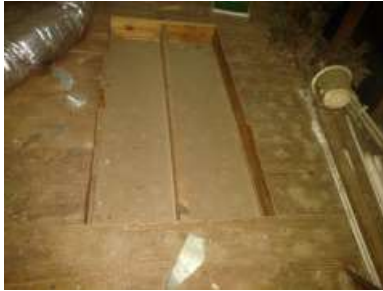
Depth & R-factor:

Insulation has been disturbed and good coverage is no longer present, Insulation is somewhat compacted and the true R-factor at this point in time may be substantially less than that originally installed. Installation of additional insulation is recommended. 3-8 inches.

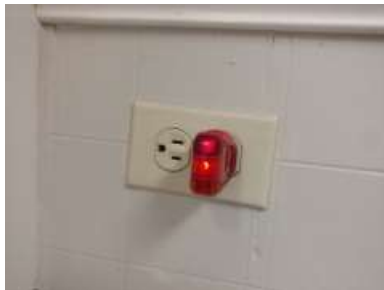
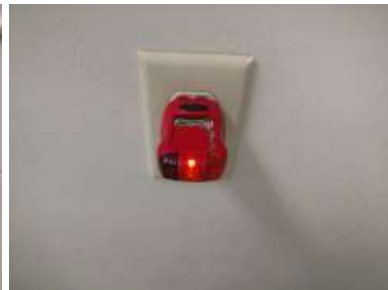
| <i>Kitchen Interior:</i> | <input type="checkbox"/> | <input checked="" type="checkbox"/> | <input type="checkbox"/> | Reverse polarity is noted, Right of sink. |
| | <input type="checkbox"/> | <input checked="" type="checkbox"/> | <input type="checkbox"/> | Some grounded type outlets did not appear to be properly grounded. Left of stove. |

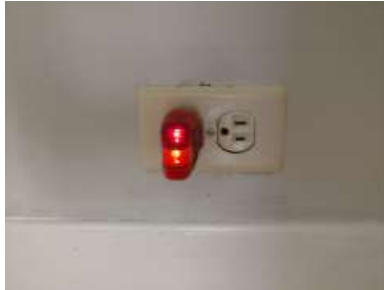
Living Room:

Reverse polarity is noted, At most outlets.

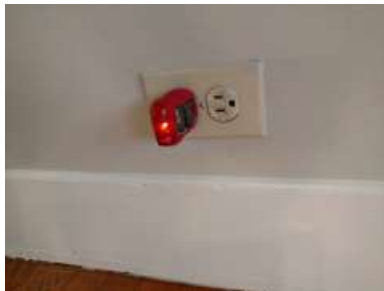
Dining Room:

Reverse polarity is noted, Under window and at wall.

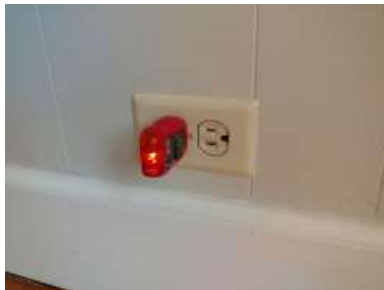
Bedroom #1: Side

Reverse polarity is noted, Outlet between built ins.

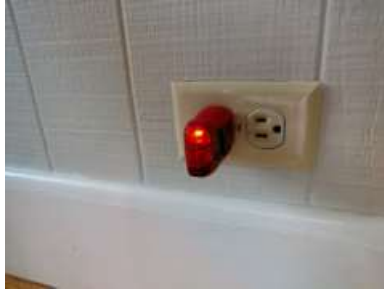
Sun Room:

OK MM RR
 Open neutral noted outlet behind door.

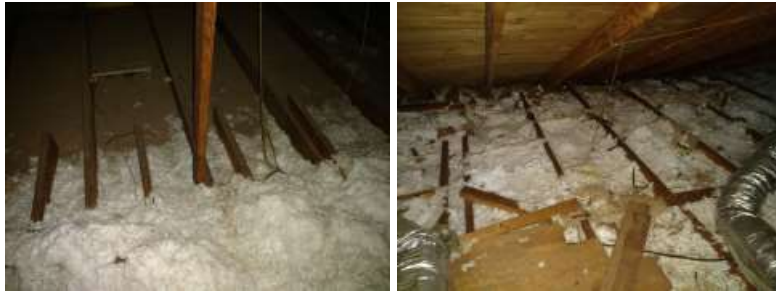
Attic & Insulation:

Visible knob and tube, visible cloth rapped. It was not determined if knob and tube is live or abandoned. Recommend further evaluation.

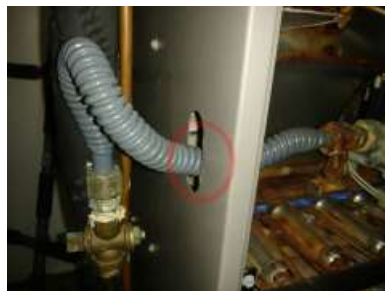
Natural Gas, it is recommended that a solid gas line be used when entering the side of a unit not a flex gas line, a rubber bushing or grommet is recommended for protection if flex line is used.

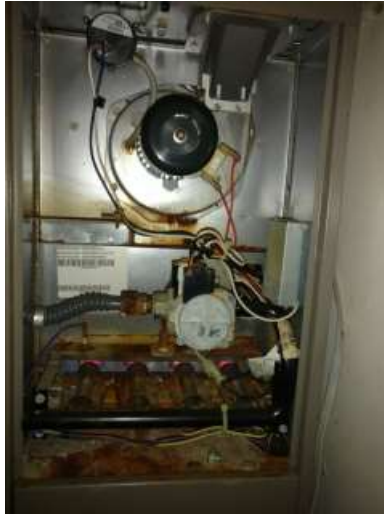
| | <input type="checkbox"/> | <input checked="" type="checkbox"/> | <input type="checkbox"/> | Some rust noted. Regular service recommended by a licensed competent a/c contractor. |

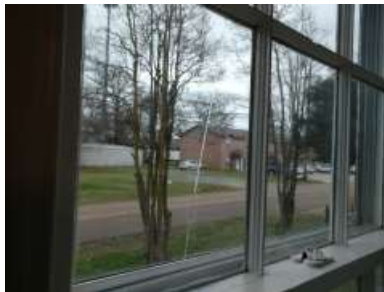
Living Room:

Cracked window noted.

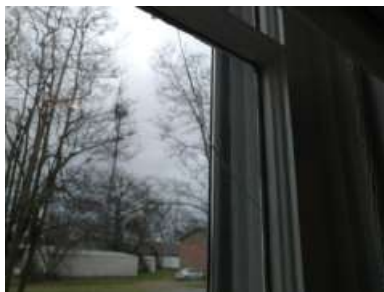
Bedroom #1: Side

Cracked window.

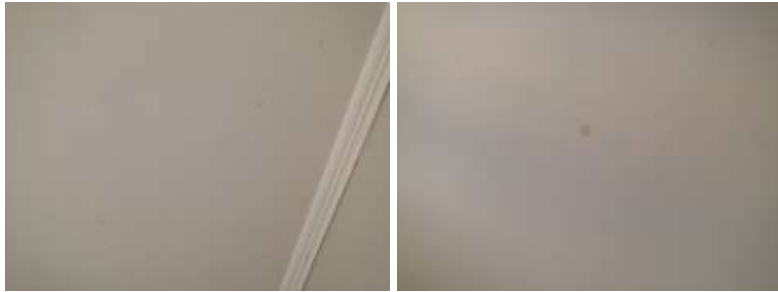
Living Room: OK MM RR Multiple small stains noted , cause not determined.

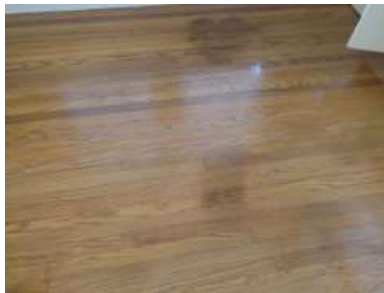
Living Room:

Discoloration noted, cause not determined. patched area from old floor heater.

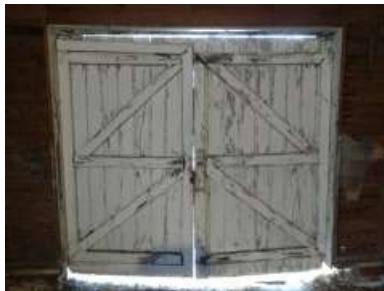
Garage Door:

Wood doors. Deterioration noted maintenance recommended.
