Report: 6027 quitman hwy, quitman 09-25-2019

Confidential Inspection Report

6027 Quitman Hwy

September 25, 2019

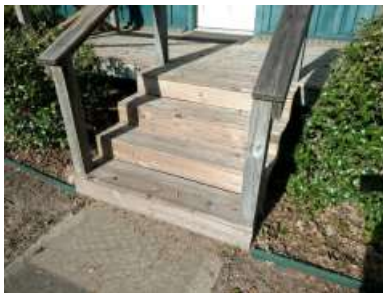
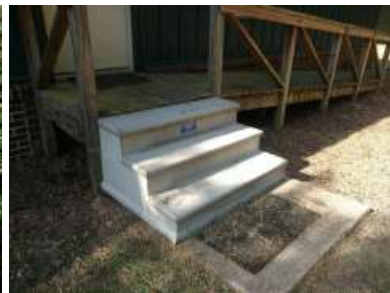
Exterior Steps / Stoops: Handrails serviceable.
 Hand rails are recommended on all steps with three or more risers. Handrails missing right side of building.

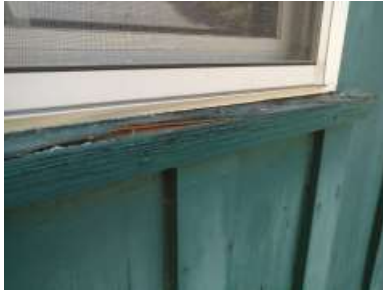
Wood.
 Wood sills rear of building weathered.

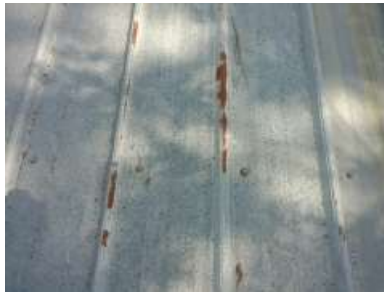
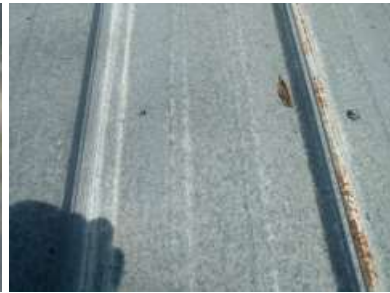
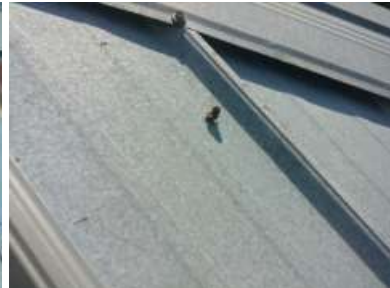
Metal is rusting in multiple areas, Missing and loose screws noted.

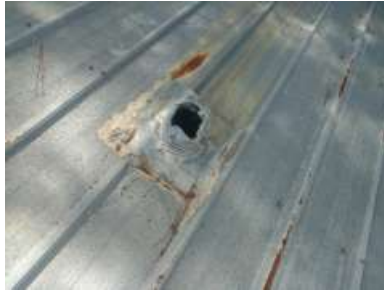
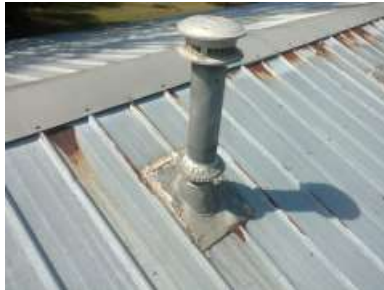
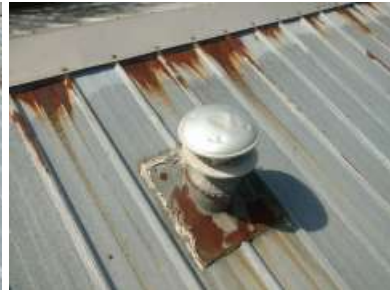
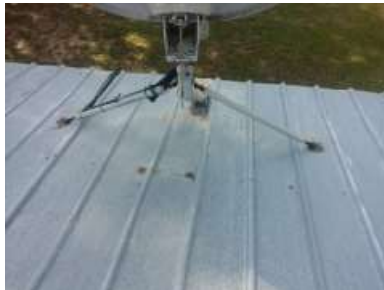
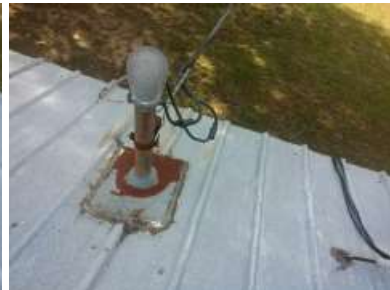
This type of flashing is not proper for metal roofs, regular maintenance recommended.

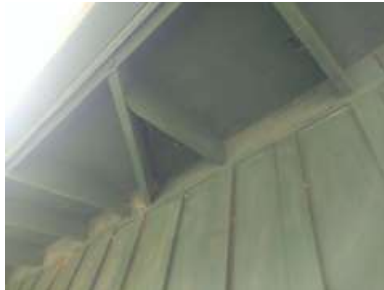
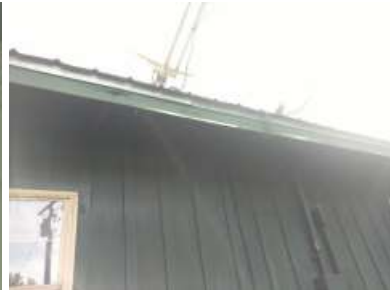
- Soffits and overhang materials are wood.
- Deterioration of fascia board and soffit left side of building.
- Peeling paint noted in multiple areas.

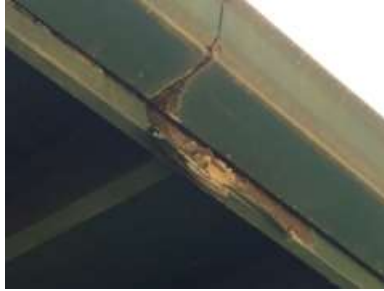
Building is partially guttered. Debris noted. Possible leaks noted at seams.

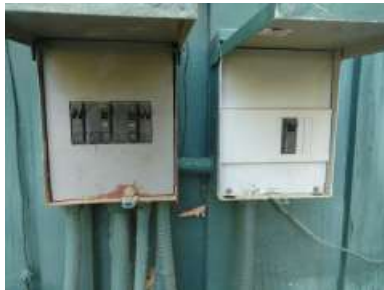
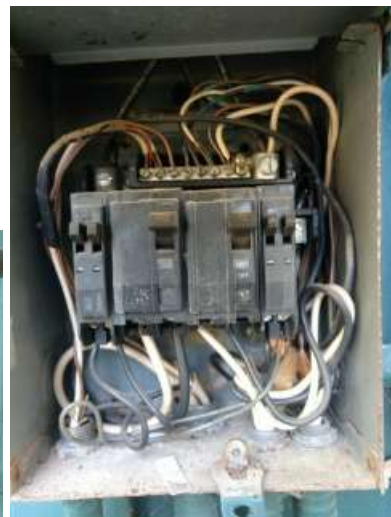
| <input type="checkbox"/> | <input checked="" type="checkbox"/> | <input type="checkbox"/> | Service lugs of left panel double tapped to provide power to right panel. Corrosion noted on some ground wires left panel. |

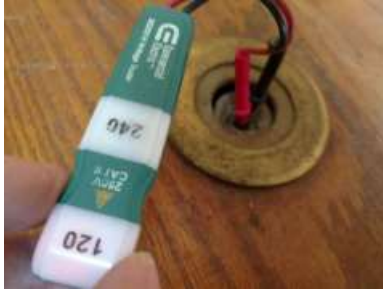
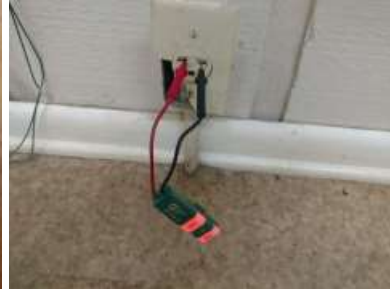
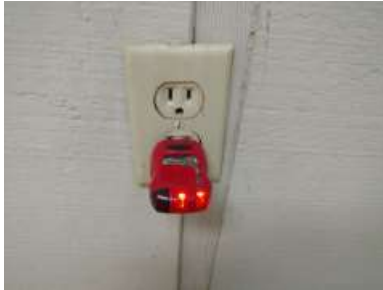
Ground Fault Circuit Interrupter (GFCI) outlets are recommended for installation at exterior, garage, bath rooms & kitchen outlets.

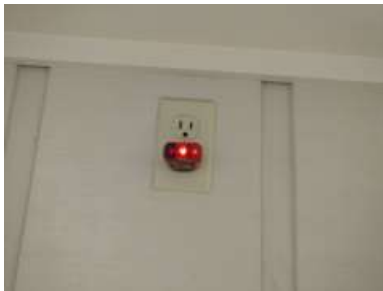
Some grounded type outlets did not appear to be properly grounded.

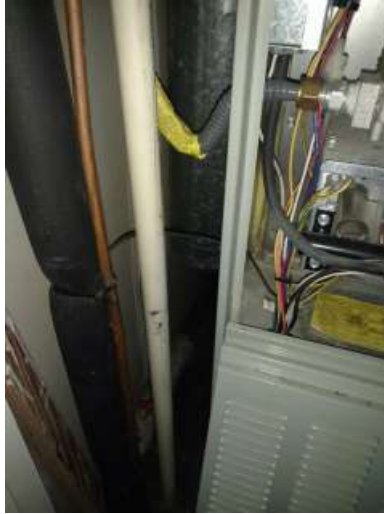
Natural Gas, it is recommended that a solid gas line be used when entering the side of a unit not a flex gas line, a rubber bushing or grommet is recommended for protection if flex line is used.

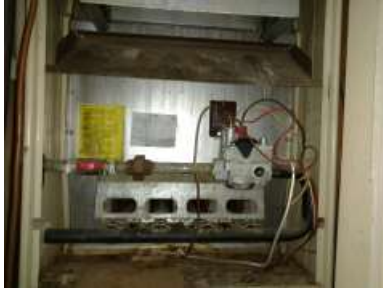
Unit fan turns on and pilot is lit, but burners do not turn on. Unit is past the normal life expectancy. Recommend further evaluation by a licensed competent a/c contractor.

Burners / Heat Exchangers: OK MM RR
 Older unit rust noted in burn chamber.

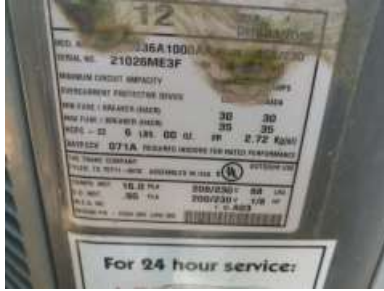
Return Air Temp: 85.

Supply Air Temp: 85.

Unit not functioning properly. No temp drop. Recommend further evaluation by a licensed competent a/c contractor.

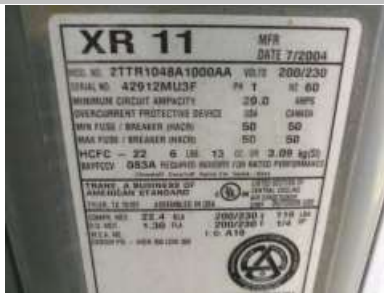
14 F Considered marginal operation.

General condition appears serviceable. Recommend service due to age and marginal temp drop.

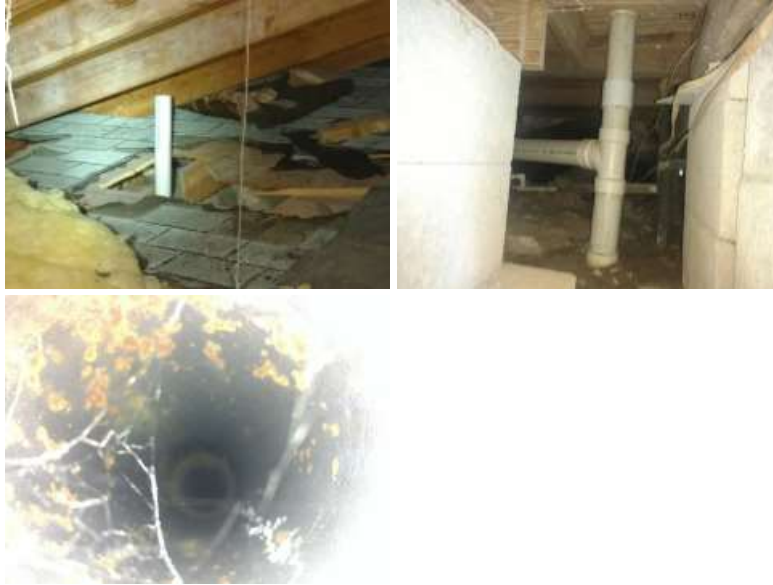
Material: Cast Iron, Plastic.
Condition: Plumbing vent vents to attic. Should vent to exterior. Vent is for kitchen.
 General condition appears serviceable.

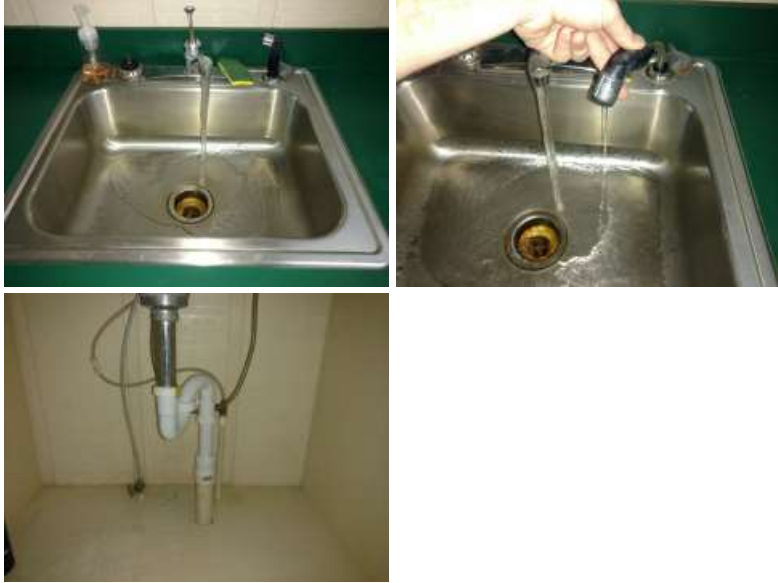
Kitchen Sink: Stainless Steel, Faucet is serviceable.
 Sprayer not functioning.
 An improper S-trap is noted. P-traps are preferred.

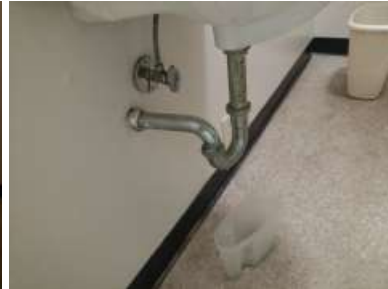
| <input type="checkbox"/> | <input checked="" type="checkbox"/> | <input type="checkbox"/> | <input type="checkbox"/> | Leak at base of sink. |

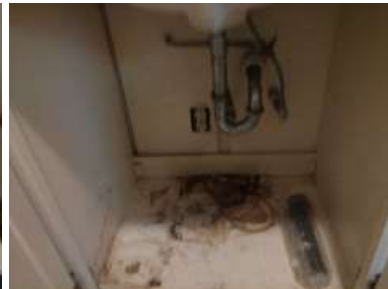
Bath: By Kitchen

| <input type="checkbox"/> | <input checked="" type="checkbox"/> | <input type="checkbox"/> | <input type="checkbox"/> | Leak at faucet. |
| <input type="checkbox"/> | <input checked="" type="checkbox"/> | <input type="checkbox"/> | <input type="checkbox"/> | Stains in cabinet. |

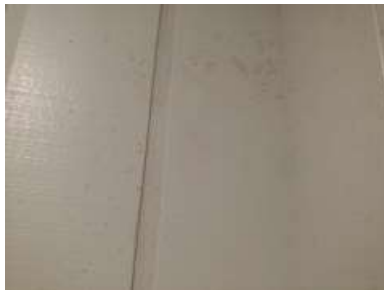
Stains.

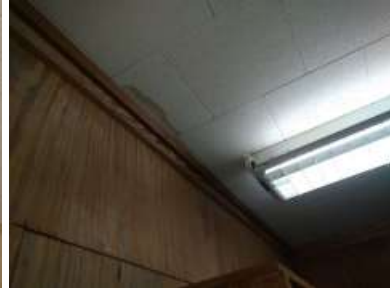
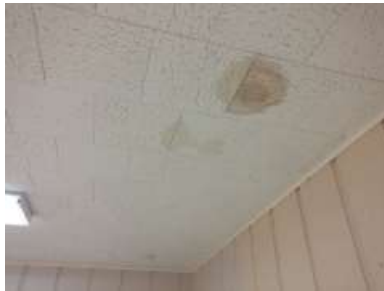
| <input type="checkbox"/> | <input checked="" type="checkbox"/> | <input type="checkbox"/> | Stains noted ceiling front hall store room. |
| <input type="checkbox"/> | <input checked="" type="checkbox"/> | <input type="checkbox"/> | Stains noted large room. |

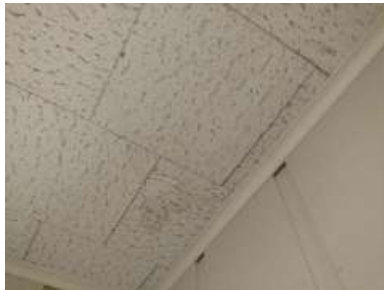
| <input type="checkbox"/> | <input checked="" type="checkbox"/> | <input type="checkbox"/> | Stain noted. |
