Confidential Inspection Report 135 Ramsey Cir Ruston, Ia

February 19, 2019

RE: 135 Ramsey Cir Ruston, la

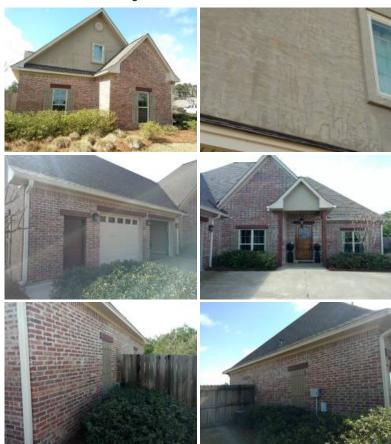
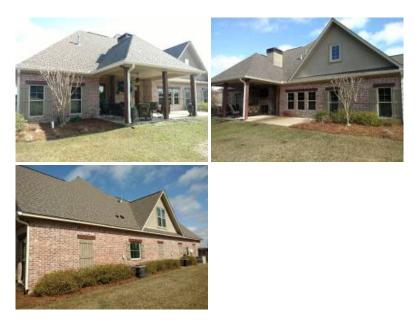
Exterior Walls: Materials & Condition: Stucco front gable, recommend further evaluation due to appearance of cracking.

☑ □ Stucco front gable, recommend further evaluation due to appearance of cracking.

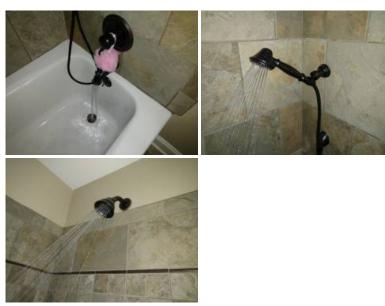
<u>Tub/Shower Fixtures:</u> Bath Between Bedrooms: Shower wand holder loose at wall.

Shower wand holder loose at wall.
