InspectionSmith 1614 Frances Place Monroe LA 71201 318-243-3912 inspectionsmithmonroe@gmail.com

Report: 2208 desiree, ruston 09-09-2019

Confidential Inspection Report 2208 Desiree Ruston, la

September 9, 2019

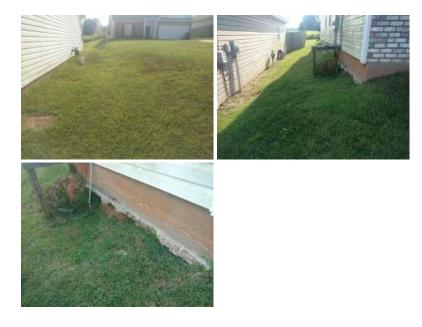
<u>Grading:</u> *Site:* Washing noted front left corner.

negative grade right side of house.
V	Washing noted front left corner.

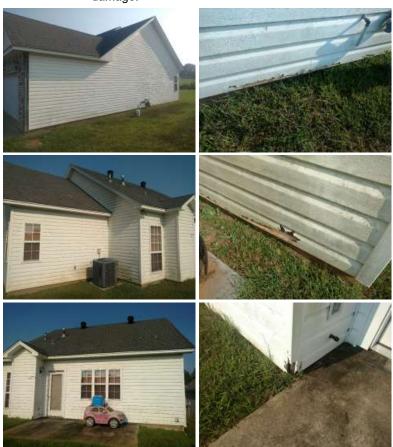
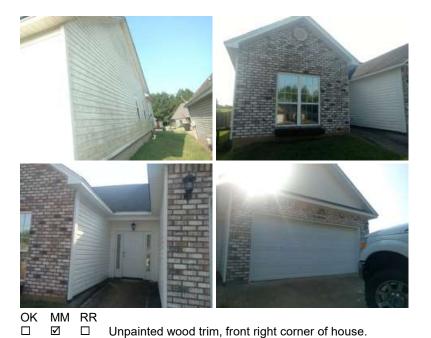
Exterior Walls: Materials & Condition: Bottom edge damaged in multiple areas appears to be weed eater damage.

- □ □ Walls are constructed with Vinyl siding.
- ☑ □ Bottom edge damaged in multiple areas appears to be weed eater damage.

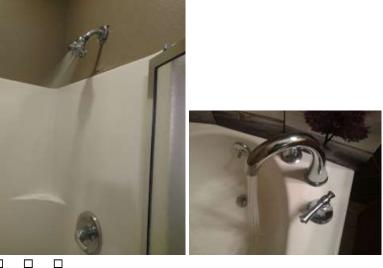
<u>Tub/Shower Fixtures:</u> Hall Bath: There is a gap between the wall and the faucet. Shower head, needs replacement.

There is a gap between the wall and the faucet.

Shower head, needs replacement.

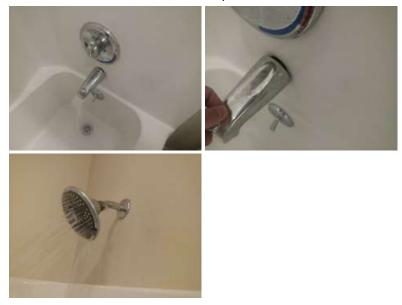
<u>Tub/Shower And Walls:</u> Master Bath: Damaged drywall under shower head appears to be from shower splash.

OK ☑	MM	Shower walls appear serviceable, Enclosure appears serviceable.
	Ø	Damaged drywall under shower head appears to be from shower splash.
A MARK	15
