InspectionSmith

Report: 2706 belcara dr, ruston 10-08-2019

Confidential Inspection Report 2706 Belcara Dr Ruston, la

October 8, 2019

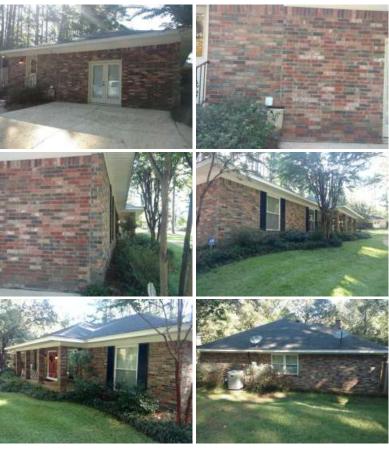
- OK MM RR $\ \square$ $\ \square$ Walls are constructed with Brick. Cracks noted are typical.
- Cold seam noted at garage enclosure.

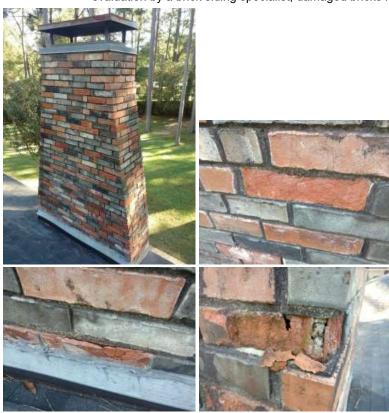
Recommend further Chimney is constructed of brick materials. evaluation by a brick siding specialist, damaged bricks noted.

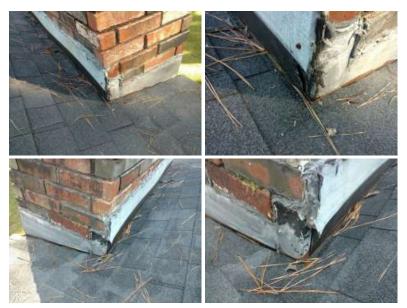
Flashing:

\checkmark Maintenance recommended.

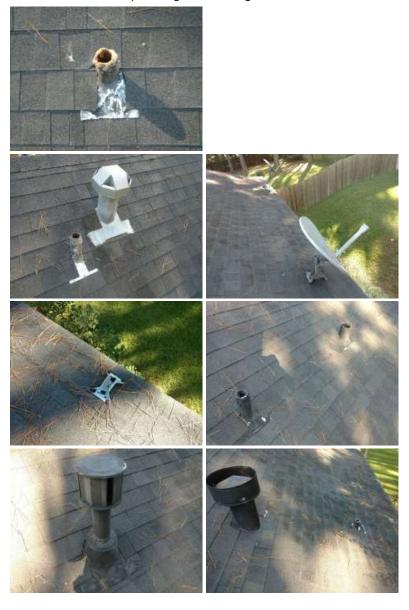
- ☐ ☐ General condition appears serviceable with signs of weathering, curling, aging, and nail pops. Regular maintenance and inspections are advised.
- $\hfill \square$ \hfill damaged edge shingles noted left side of house.
- □ ☑ □ Blistering noted at ridge shingles.

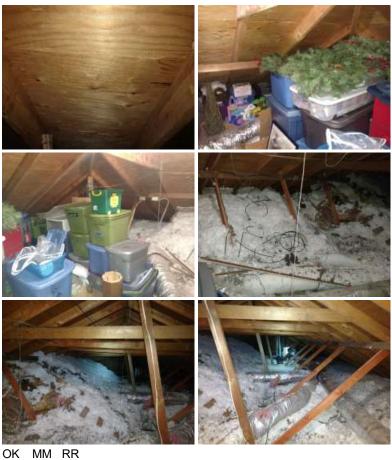
Structure:

- □ □ SHEATHING- The roof decking material is 1/2" plywood sheeting. The builder did not install ply clips during installation, which may result in sagging at the joints of the sheeting.
- \square \square A rafter system is installed in the attic cavity to support the roof decking.
