Report: 901 orleans dr, ruston 01-14-2020

Confidential Inspection Report 901 Orleans Dr Ruston, la

January 14, 2020

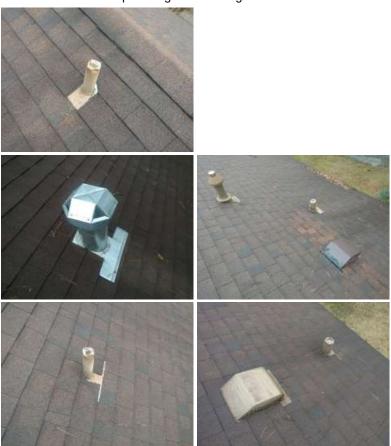
Flashings:

$\begin{array}{cccc} \mathsf{OK} & \mathsf{MM} & \mathsf{RR} \\ \hline \boxtimes & \square & \square & \mathsf{Metal plumbing vent flashings}. \end{array}$

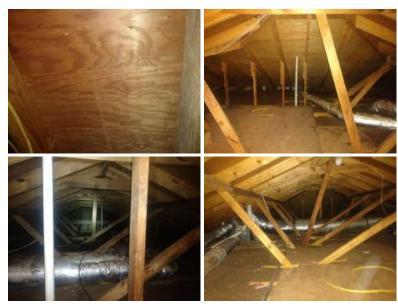
Attic & Insulation:

Access:	\checkmark		Attic is full size, Viewing was limited.
Structure:			SHEATHING- The roof decking material is 1/2" plywood sheeting. The builder did not install ply clips during installation, which may result in sagging at the joints of the sheeting.
			A rafter system is installed in the attic cavity to support the roof decking.
