# **Confidential Inspection Report**

## **180 Jefferson Oaks Ruston, la**

**August 19, 2019**

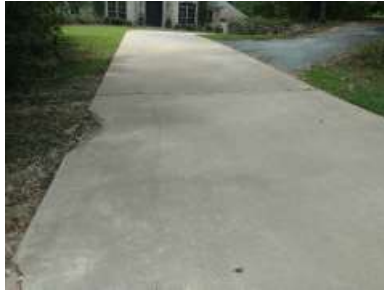
*Driveway:* OK MM RR  
   Driveway Type: Concrete, Cracks noted are typical.

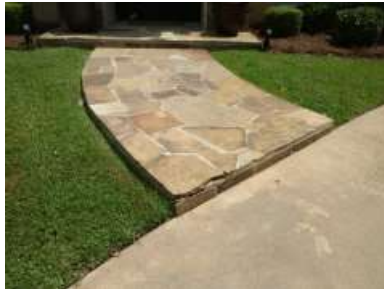
*Walks:*    Sidewalk type: Concrete, Flagstone, Cracks noted are typical.

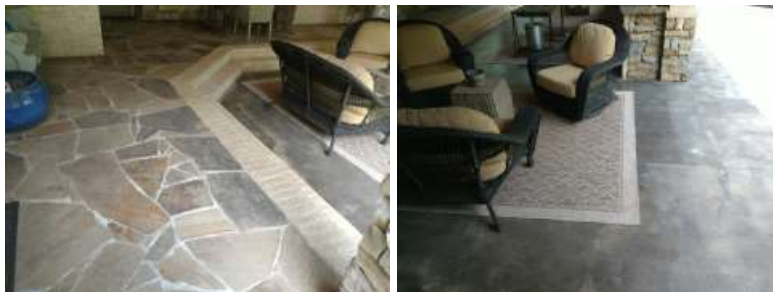
*Slab:*    Patio type: Concrete, flagstone. Cracks noted - typical.

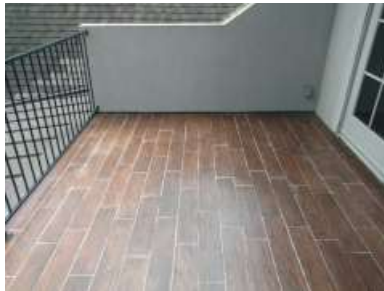
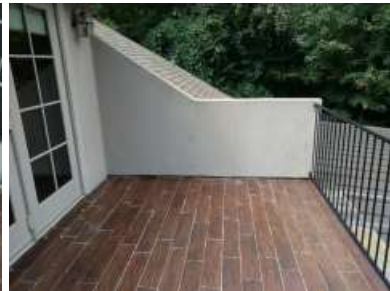
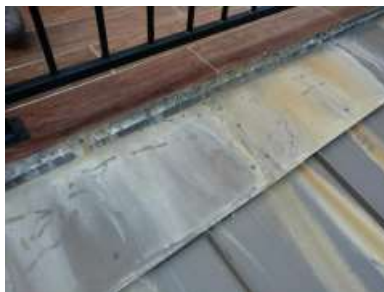
General condition appears serviceable.  
   it was not determined if balcony has proper water proofing. no stains noted under balcony. streaks on metal roof cause not determined.

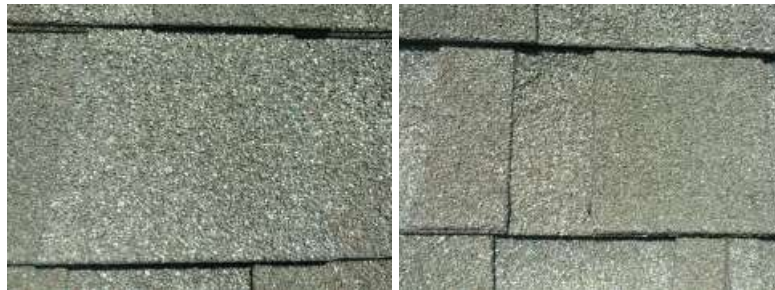
<i>Roof Covering Condition:</i>	<input checked="" type="checkbox"/> <input type="checkbox"/> <input type="checkbox"/> General condition appears serviceable with signs of weathering, curling, and aging. appears to be original to house. Regular maintenance and inspections are advised.
	<input type="checkbox"/> <input type="checkbox"/> <input type="checkbox"/> Some wear from foot traffic is noted.
	<input type="checkbox"/> <input type="checkbox"/> <input type="checkbox"/> patch noted rear of house.

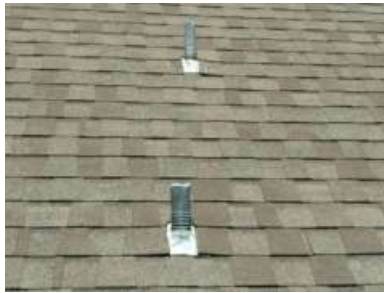
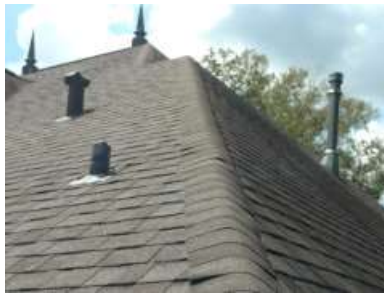
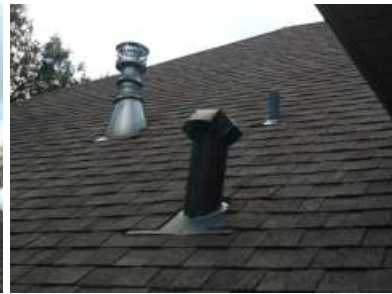
OK MM RR  
   Metal plumbing vent flashing. Metal flues.

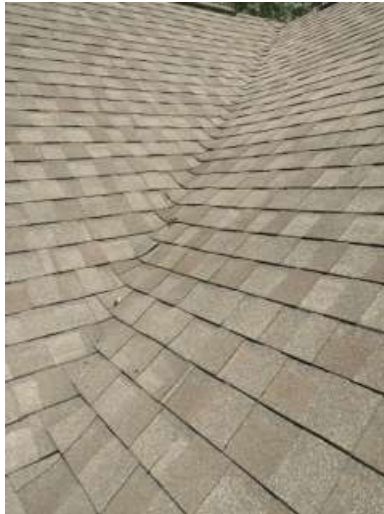
The valleys appear to be in satisfactory condition.

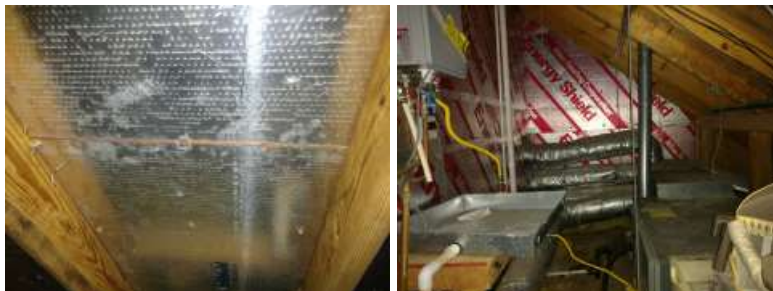
- SHEATHING- The roof decking material is oriented strand board sheathing. The builder installed ply clips when installing the sheathing to prevent the sheathing from sagging at the joints.
- The rafters or truss system appears to be in satisfactory condition.

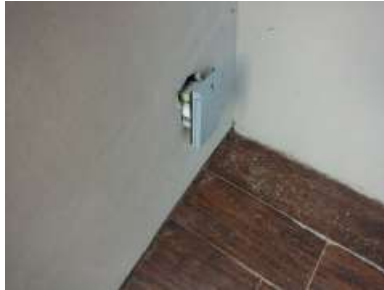
**Outlet:**

outlet loose from wall.

<i>Decks / Balcony:</i>	<input type="checkbox"/>	<input checked="" type="checkbox"/>	<input type="checkbox"/>	outlet loose from wall.
-------------------------	--------------------------	-------------------------------------	--------------------------	-------------------------

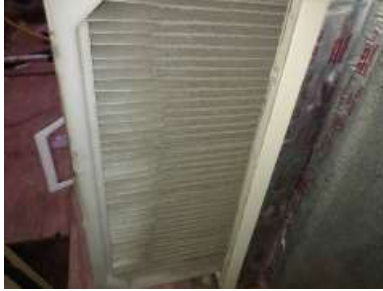
<i>Air Filters:</i>	<input type="checkbox"/>	<input type="checkbox"/>	<input checked="" type="checkbox"/>	The filter is in need of cleaning or replacement. Replacing or cleaning filters every 30 to 45 days is recommended.

The filter at unit is in need of replacement.

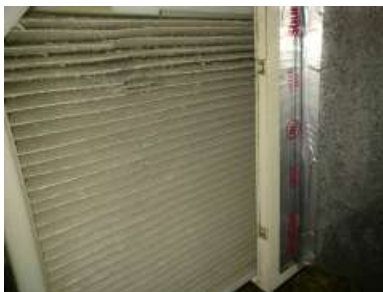
The filter is in need of cleaning or replacement. Replacing or cleaning filters every 30 to 45 days is recommended.

The filter at unit is in need of replacement.

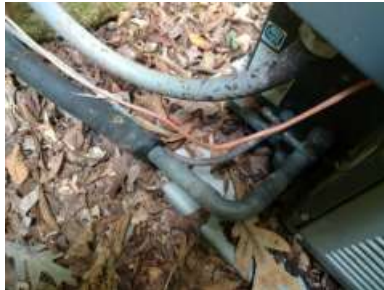
Recommend further evaluation by a licensed competent a/c contractor due to poor temp drop.

Recommend further evaluation by a licensed competent a/c contractor due to poor temp drop and condensation noted in overflow pan.

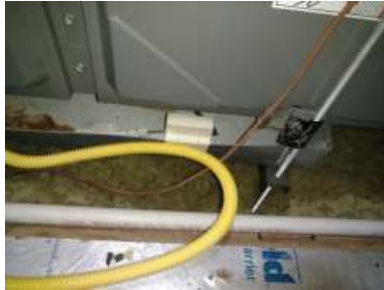
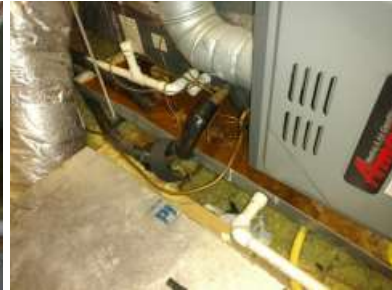
water noted in overflow pan. Further evaluation recommended.

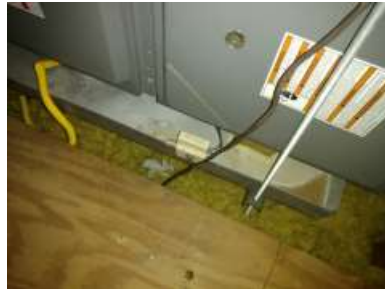
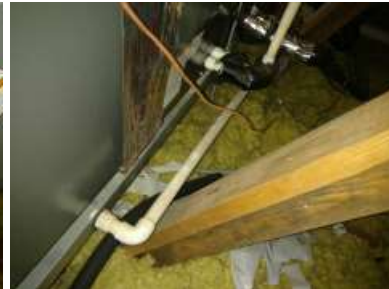
Condensate line installed, A condensate overflow pan is present. safety switch installed.

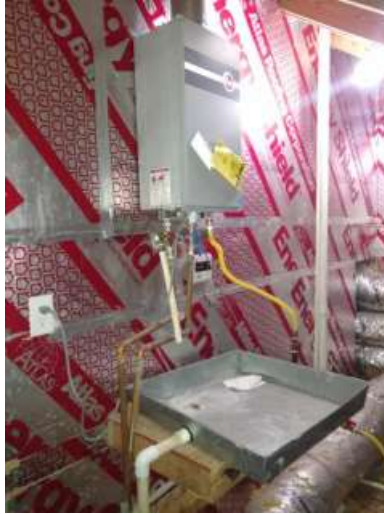
*Condition:*    Appears serviceable, Pressure relief valve noted, not tested, Flue vent intact, A water shutoff valve is installed. over flow pan installed.

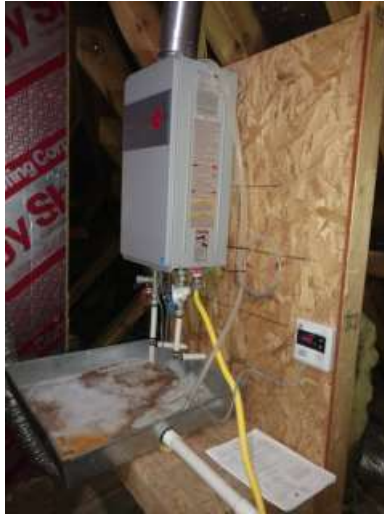
Appears serviceable, Pressure relief valve noted, not tested, Flue vent intact, A water shutoff valve is installed. overflow pan installed.

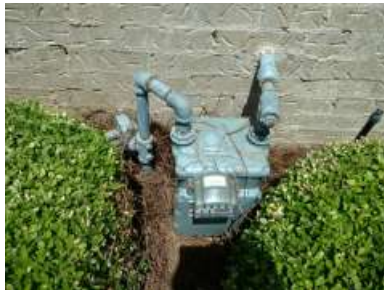
Meter located at exterior, System appears serviceable, main shut off is located at meter. Right side of house.

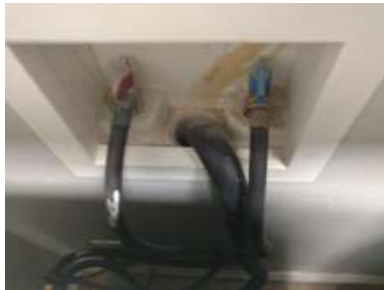
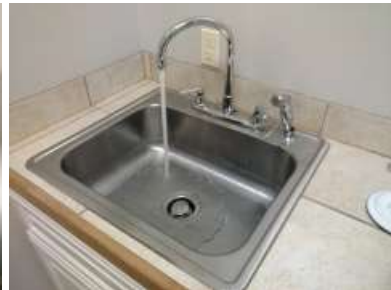
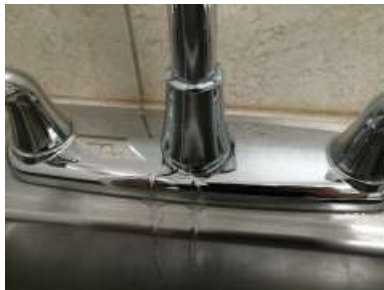
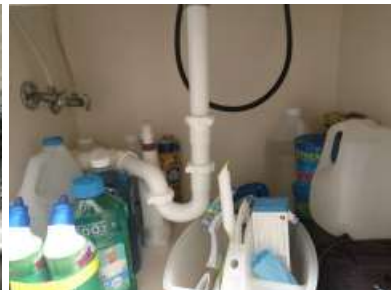
Sink faucet leaks. at faucet neck.

Laundry:    Plumbing appears serviceable.  
   Sink faucet leaks. at faucet neck.

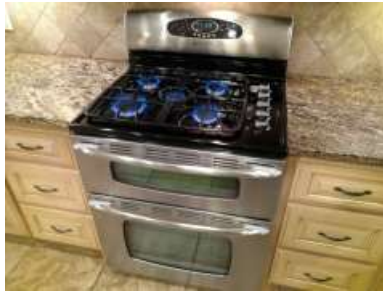
Gas, Appears serviceable, Top oven, does not function on the bake setting.

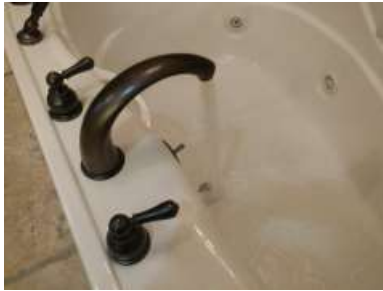
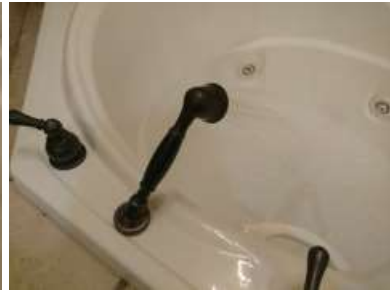
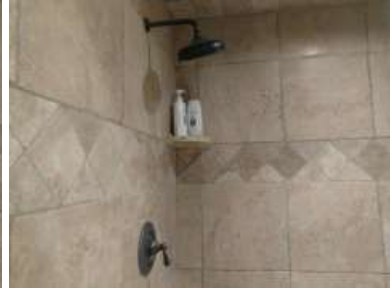
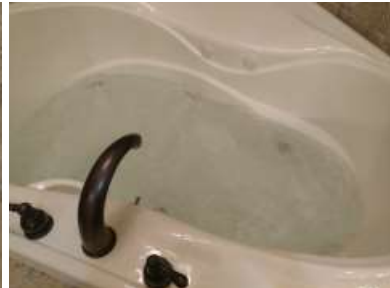
general condition of fixtures appears serviceable.  
   Jet tub functions, it was not determined if tub is GFCI protected.

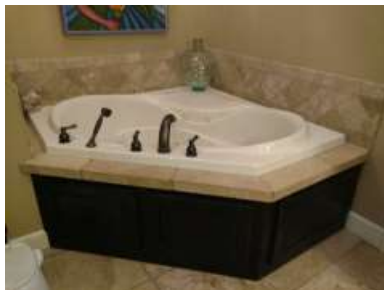
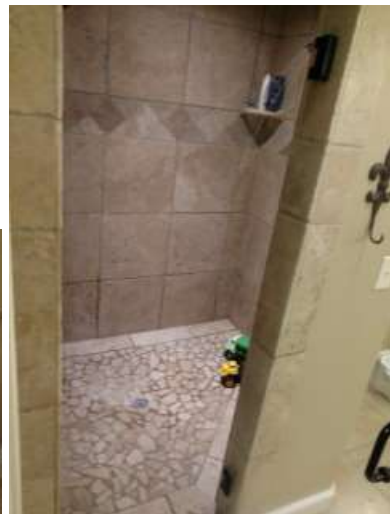
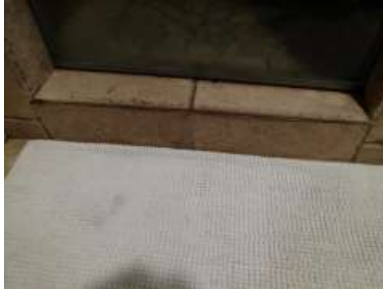
cracked mortar at step into shower. Caulk and seal all tub and shower areas as a precaution.

Shower walls appear serviceable, Enclosure appears serviceable.  
   crack noted at mortar at step into shower. Caulk and seal all tub and shower areas as a precaution.

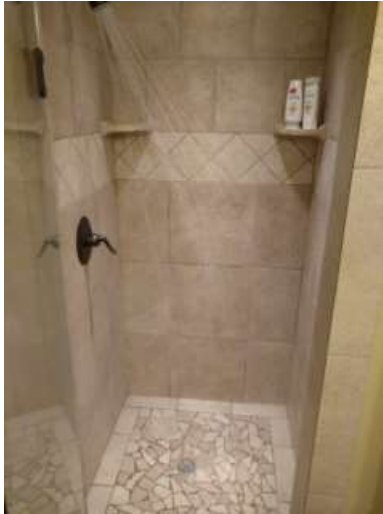
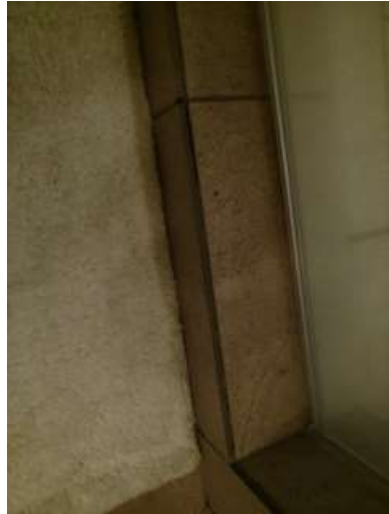
cracked mortar at step into shower. Caulk and seal all tub and shower areas as a precaution.

- Shower walls appear serviceable, Enclosure appears serviceable.
- cracked mortar at step into shower. Caulk and seal all tub and shower areas as a precaution.

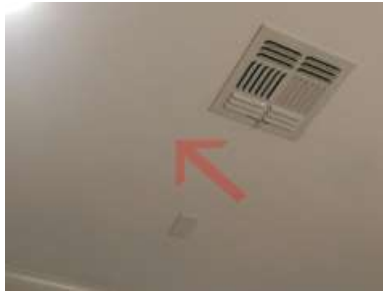
There is some minor cracking noted. Be sure to take note of any future movement. Most minor cracking is due to shrinkage of the construction materials.

<i>General Type &amp; Condition:</i>	<input checked="" type="checkbox"/>	<input type="checkbox"/>	<input type="checkbox"/>	Drywall, General condition appears serviceable, Typical cracks noted.
<i>Kitchen Interior:</i>	<input type="checkbox"/>	<input checked="" type="checkbox"/>	<input type="checkbox"/>	There is some minor cracking noted. Be sure to take note of any future movement. Most minor cracking is due to shrinkage of the construction

materials.

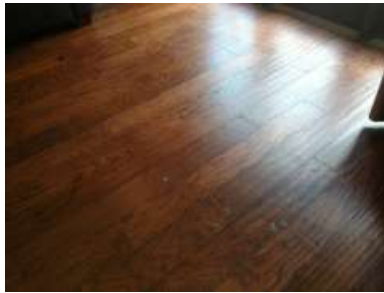
General:	<input checked="" type="checkbox"/>	<input type="checkbox"/>	<input type="checkbox"/>	General condition of flooring throughout the home are in serviceable condition.
Kitchen Interior:	<input checked="" type="checkbox"/>	<input type="checkbox"/>	<input type="checkbox"/>	
Master Bath:	<input checked="" type="checkbox"/>	<input type="checkbox"/>	<input type="checkbox"/>	
Hall Bath: Upstairs	<input checked="" type="checkbox"/>	<input type="checkbox"/>	<input type="checkbox"/>	
Bath: Top Of Stairs	<input checked="" type="checkbox"/>	<input type="checkbox"/>	<input type="checkbox"/>	
Half Bath:	<input checked="" type="checkbox"/>	<input type="checkbox"/>	<input type="checkbox"/>	
Entry / Foyer / Hall:	<input checked="" type="checkbox"/>	<input type="checkbox"/>	<input type="checkbox"/>	
Living Room:	<input checked="" type="checkbox"/>	<input type="checkbox"/>	<input type="checkbox"/>	
Living Room: Upstairs	<input checked="" type="checkbox"/>	<input type="checkbox"/>	<input type="checkbox"/>	Wear and tear noted.

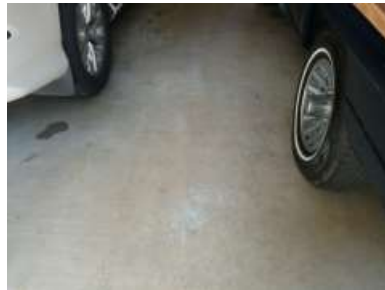
Typical cracks noted.
