Report: 2309 desiree, ruston 09-09-2019

Confidential Inspection Report

2309 Desiree Ruston, la

September 9, 2019

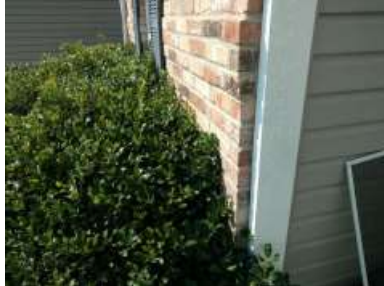
Trim plants away from structure.

Landscaping: Condition:
Trim plants away from structure.

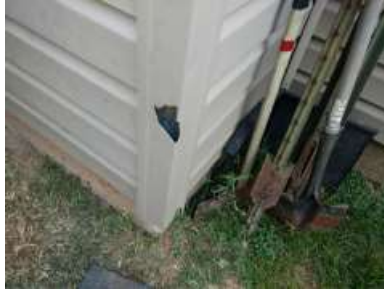
Vinyl materials. Damaged corner trim.

Exterior Walls: Trim:
Vinyl materials. Damaged corner trim.

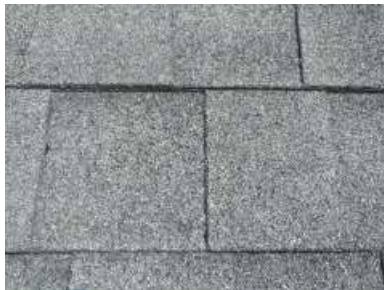
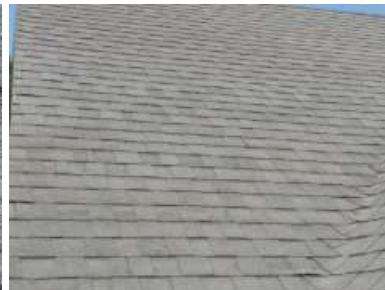
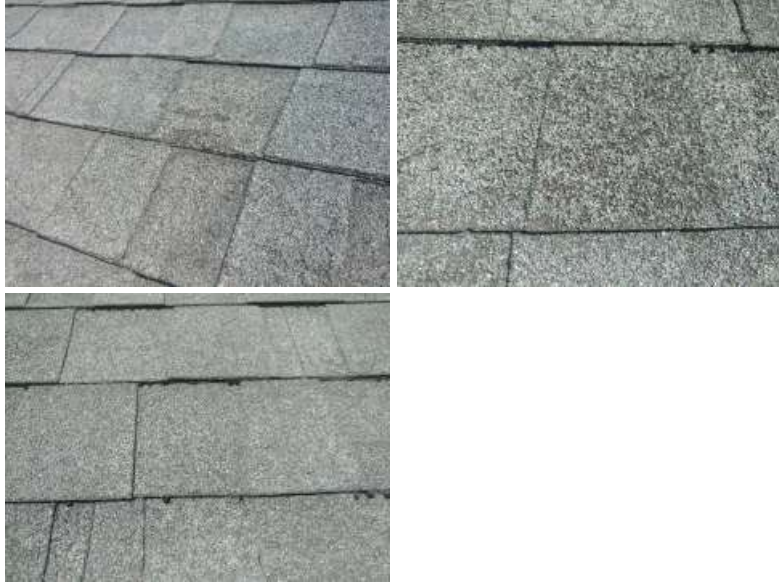
General condition appears serviceable with signs of weathering, curling, aging, and nail pops. Regular maintenance and inspections are advised.

Patch front left side.

Heavy wear noted in multiple areas. Recommend further evaluation by a licensed competent roofing contractor.

Roof: Roof Covering Condition:
Heavy wear noted in multiple areas. Recommend further evaluation by a licensed competent roofing contractor.

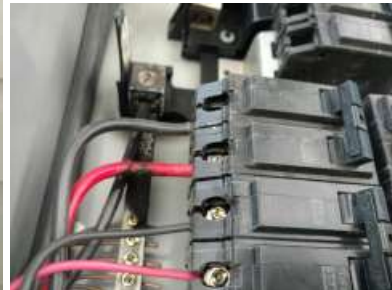
- Circuit and wire sizing correct so far as visible, Grounding system is present.
- Scorched wire noted at 50amp breaker top left of panel, labeled range. Further evaluation and repair as needed is recommended by a licensed competent electrician.

Electrical Distribution Panels: Main Panel Observations:
Scorched wire noted at 50amp breaker top left of panel, labeled range. Further evaluation and repair as needed is recommended by a licensed competent electrician.

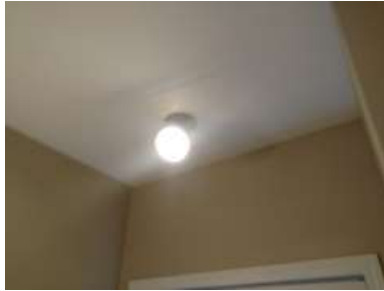
| | <input type="checkbox"/> | <input checked="" type="checkbox"/> | <input type="checkbox"/> | Can light loose from ceiling. |

Master Bath:
Can light loose from ceiling.

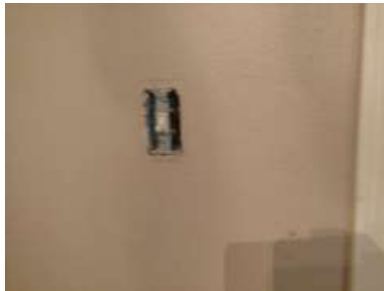
| <i>Entry / Foyer / Hall:</i> | <input type="checkbox"/> | <input checked="" type="checkbox"/> | <input type="checkbox"/> | Switch cover missing. |

Entry / Foyer / Hall:
Switch cover missing.

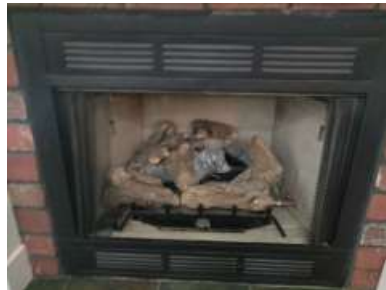
Vent less gas logs. Logs not set properly and damaged. Could not get pilot to stay lit.

Vent less gas logs. Logs not set properly and damaged. Could not get pilot to stay lit.

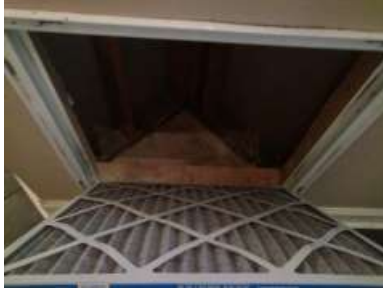
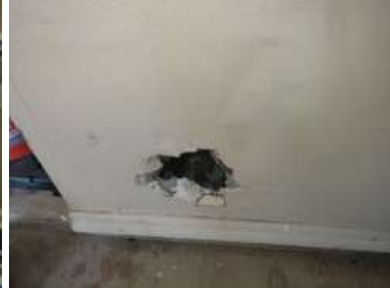
| <input type="checkbox"/> | <input checked="" type="checkbox"/> | <input type="checkbox"/> | Hole in garage wall, is at a/c return duct under unit. A/c is drawing air from garage. Possible cause of dust at ceiling vents. possible safety hazard. |

Hole in garage wall, it is at a/c return duct under unit. A/c is drawing air from garage. Possible cause of dust at ceiling vents. possible safety hazard.

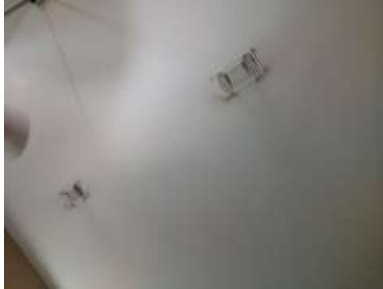
| <input type="checkbox"/> | <input type="checkbox"/> | <input type="checkbox"/> | Dust at vents. |

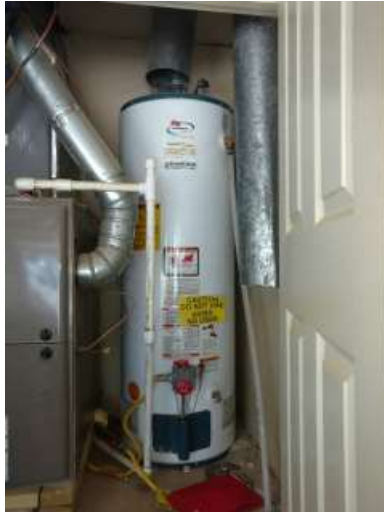
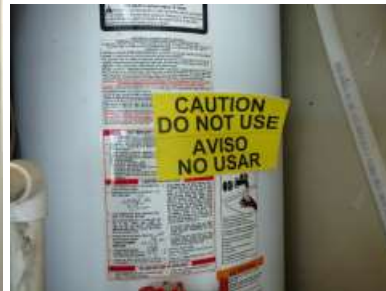
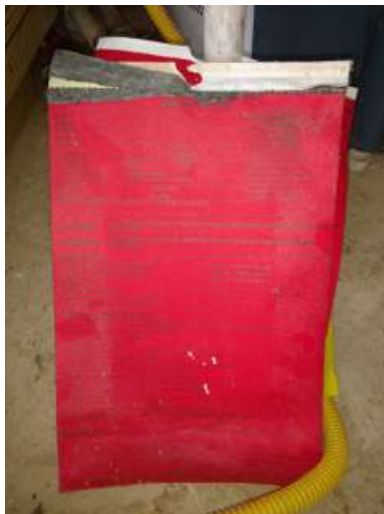
There is a do not use sign on the water heater, it was placed by the gas company appears to be 2017, a list of issues was placed by unit, it is red paper. unit is functioning. Gas sniff test is outside the scope of this inspection. Recommend consulting with owner for receipt of repairs.

There is a do not use sign on the water heater, it was placed by the gas company appears to be 2017, a list of issues was placed by unit, it is red paper. unit is functioning. Gas sniff test is outside the scope of this inspection. Recommend consulting with owner for receipt of repairs.

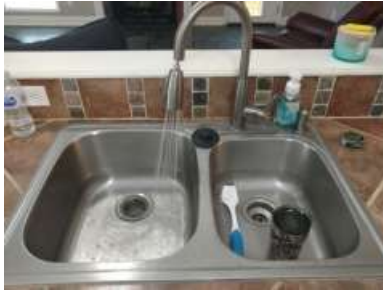
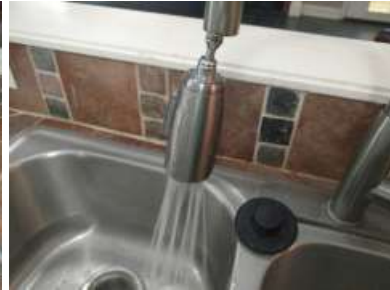
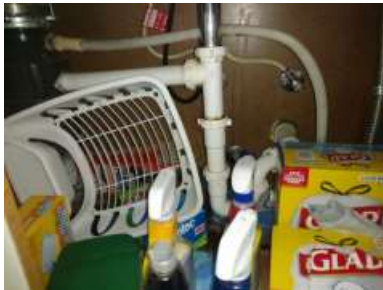
- Faucet is serviceable.
- Sprayer leaks at head.
- under sink drain appears serviceable.

Sprayer leaks at head.

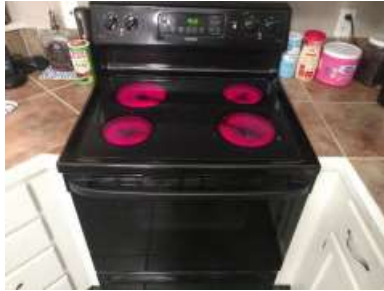
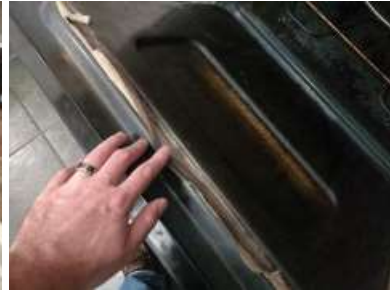
| <input type="checkbox"/> | <input checked="" type="checkbox"/> | <input type="checkbox"/> | Heat gasket around range door is damaged. |

Heat gasket around range door is damaged.

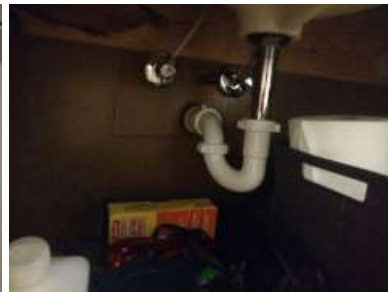
| <input type="checkbox"/> | <input checked="" type="checkbox"/> | <input type="checkbox"/> | Sink drains slow. |

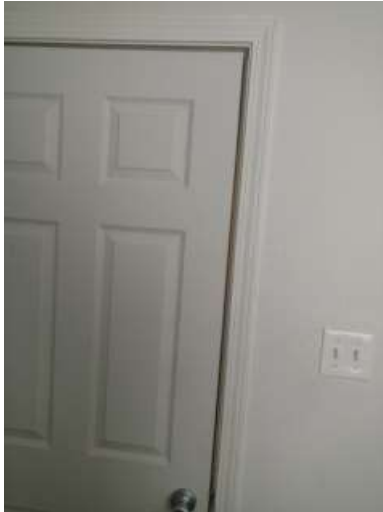
| | OK | MM | RR | |
|---|---|---|---|---|
| Bedroom #2: Front | <input type="checkbox"/> | <input checked="" type="checkbox"/> | <input type="checkbox"/> | Door not proper size. |

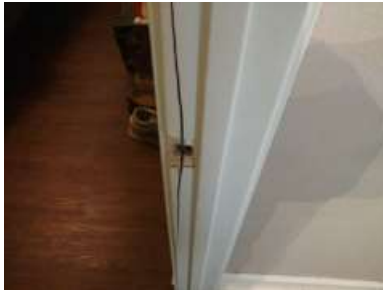
| Bedroom #3: Middle | <input type="checkbox"/> | <input checked="" type="checkbox"/> | <input type="checkbox"/> | Door frame damaged. |

Door frame damaged.

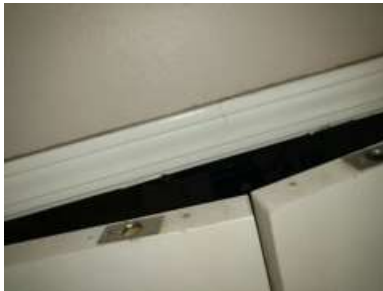
| Laundry: | <input type="checkbox"/> | <input checked="" type="checkbox"/> | <input type="checkbox"/> | Latches at top of door missing. |

Latches at top of door missing.

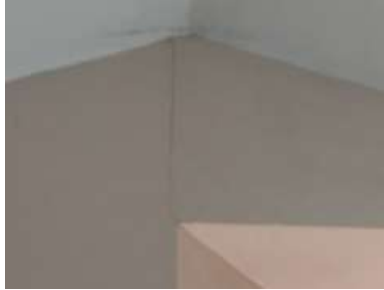
| | OK | MM | RR | |
|---|---|---|---|---|
| Living Room: | <input type="checkbox"/> | <input checked="" type="checkbox"/> | <input type="checkbox"/> | There is some minor cracking noted. Be sure to take note of any future movement. Most minor cracking is due to shrinkage of the construction materials. |

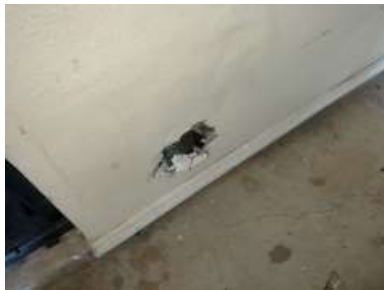
- Drywall, General condition appears serviceable, Hole in wall.

Drywall, General condition appears serviceable, Hole in wall.
