Report: 6027 quitman hwy, quitman 09-25-2019

Confidential Inspection Report

6027 Quitman Hwy

September 25, 2019

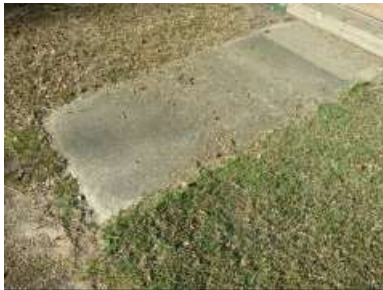
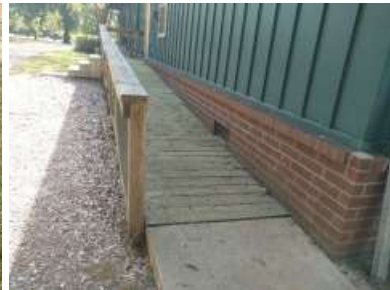
Walks: Sidewalk type: Concrete, Cracks noted are typical.
 Sidewalk type: Wood deck right side of building handicap ramp.

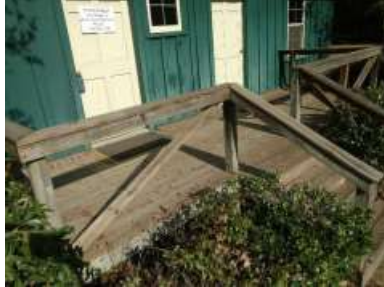
Structure:

It is recommended balusters be no more than 4 inches apart.

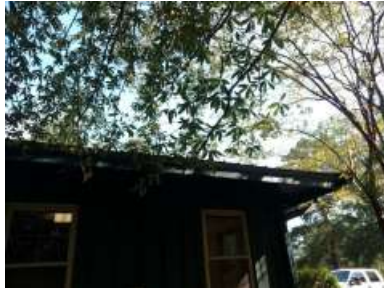
Condition:

Trim plants away from structure.

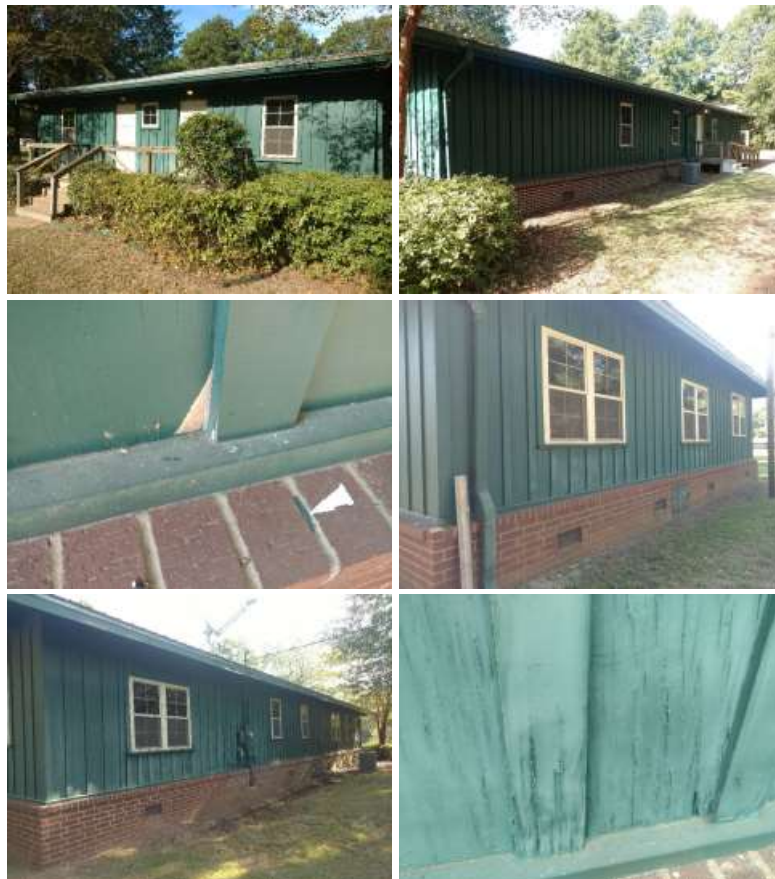
Materials & Condition:

| <input type="checkbox"/> | <input checked="" type="checkbox"/> | <input type="checkbox"/> | Multiple small areas of chipping or peeling paint. |

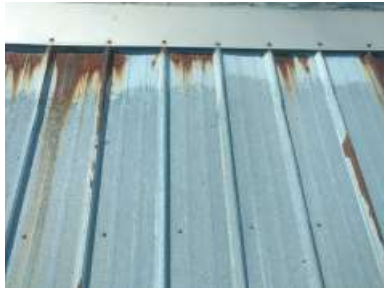
Roof Covering Condition:

Metal is rusting in multiple areas, Missing and loose screws noted.

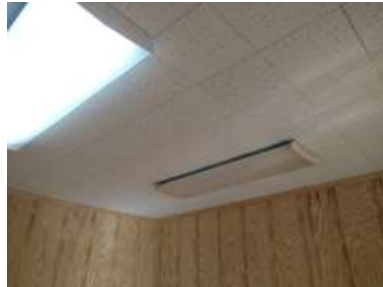
| <input type="checkbox"/> | <input checked="" type="checkbox"/> | <input type="checkbox"/> | A representative sampling of switches was tested. As a whole, switches throughout the house are in serviceable condition. Lights are not operational in some areas, possibly due to bad bulbs, Multiple switches function not identified. |

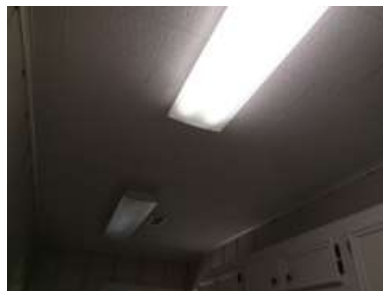
Kitchen Interior:

| <input checked="" type="checkbox"/> | <input type="checkbox"/> | <input type="checkbox"/> | A representative sampling of switches was tested. As a whole switches throughout the room are in serviceable condition. Some switches not function not identified. |

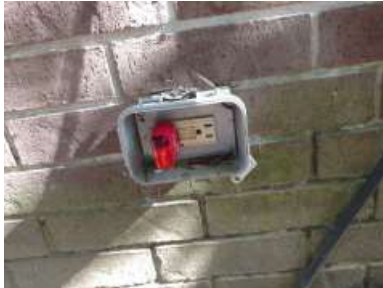
Exterior Walls:

Cover for exterior outlet left side of building missing.

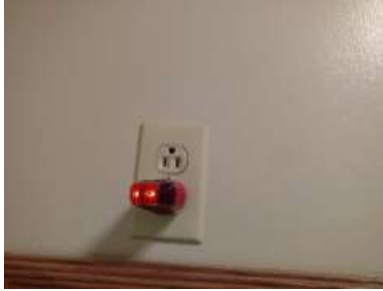
Bath: Front Office

A representative sampling of outlets was tested. As a whole, outlets throughout the room are in serviceable condition.

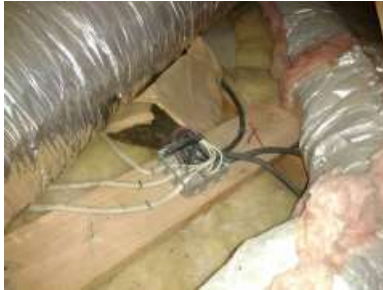
Attic & Insulation:

Appears serviceable, Open junction boxes are noted.

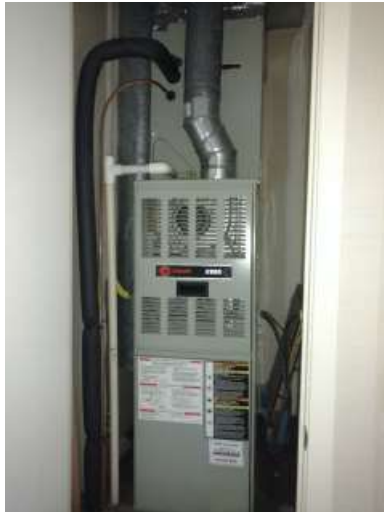
Type & Location:

Forced Air.

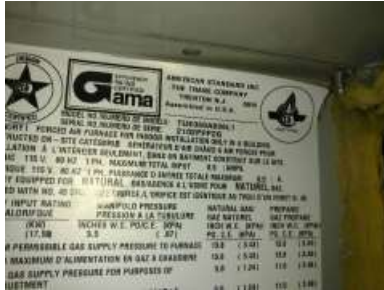
Capacity / Approx. Age:

2002.

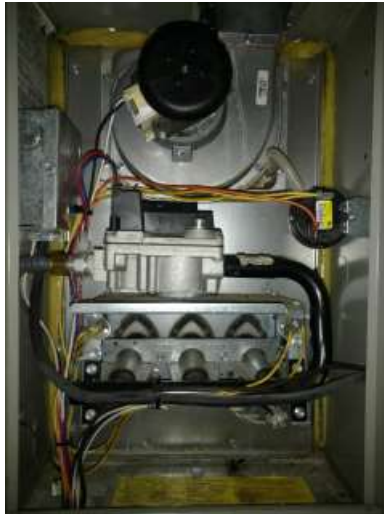
General Operation & Cabinet:
Burners / Heat Exchangers:

OK MM RR
 Unit was operational at the time of inspection.

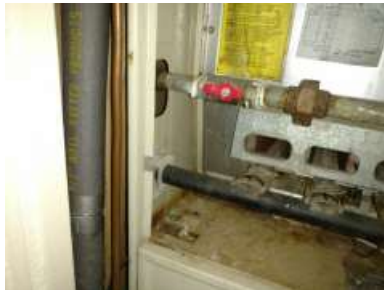
Fuel Source:

Natural Gas, Gas shut off valve inside unit. Not proper, valve should not be in a concealed place and should be separate from the unit.

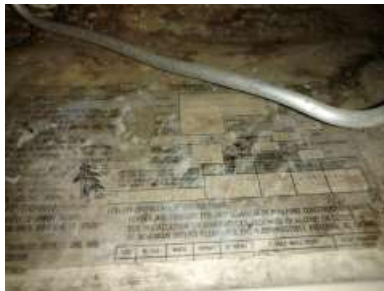
Capacity / Approx. Age:

1983.

Unit fan turns on and pilot is lit, but burners do not turn on. Unit is past the normal life expectancy. Recommend further evaluation by a licensed competent a/c contractor.

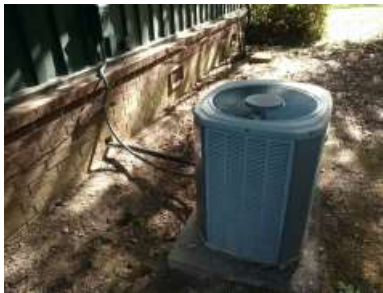
Air Conditioning: Front Area

Primary Type: Central, Split System- Front area.

Unit not functioning properly. No temp drop. Recommend further evaluation by a licensed competent a/c contractor.

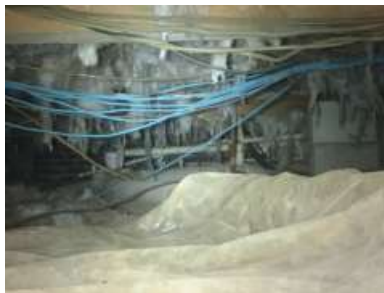
Supply Lines:

Material: Plastic-
 OK MM RR
Condition: General condition appears serviceable.

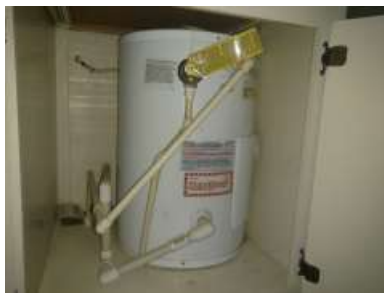
Power Source: Electric. **Capacity:** 10. **Location:** Kitchen.

Condition: Pressure relief valve noted, not tested, A water shutoff valve is installed, unit was off at time of inspection. Breaker was off.

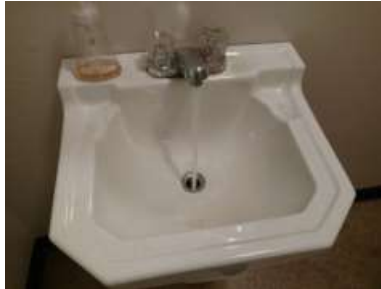
| <input type="checkbox"/> | <input checked="" type="checkbox"/> | <input type="checkbox"/> | <input type="checkbox"/> | Leak at base of sink. |

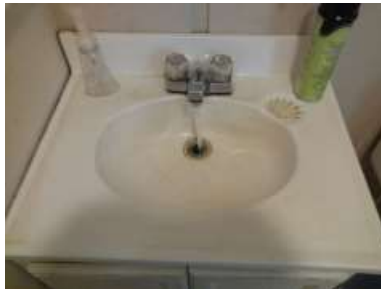
Bath: By Kitchen

| <input type="checkbox"/> | <input checked="" type="checkbox"/> | <input type="checkbox"/> | <input type="checkbox"/> | Leak at faucet. |
| <input type="checkbox"/> | <input checked="" type="checkbox"/> | <input type="checkbox"/> | <input type="checkbox"/> | Stains in cabinet. |

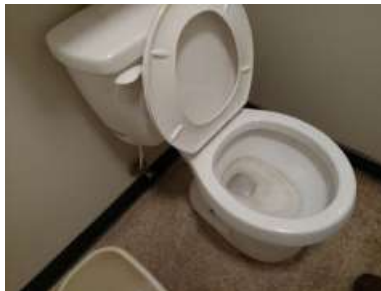
Bath: Front Office

| <input type="checkbox"/> | <input checked="" type="checkbox"/> | <input type="checkbox"/> | <input type="checkbox"/> | General condition appears serviceable. Loose at floor. |

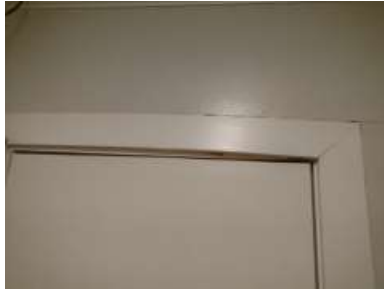
Bath: Front Office

OK MM RR
 Door frame has been trimmed.

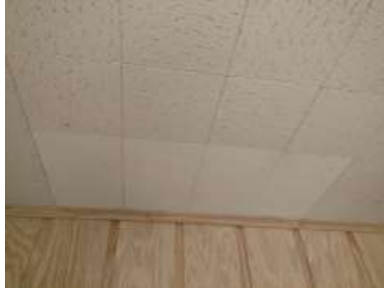
| <input type="checkbox"/> | <input checked="" type="checkbox"/> | <input type="checkbox"/> | Patched tiles noted. |
| <input type="checkbox"/> | <input checked="" type="checkbox"/> | <input type="checkbox"/> | Stains noted ceiling front hall store room. |
| <input type="checkbox"/> | <input checked="" type="checkbox"/> | <input type="checkbox"/> | Stains noted large room. |

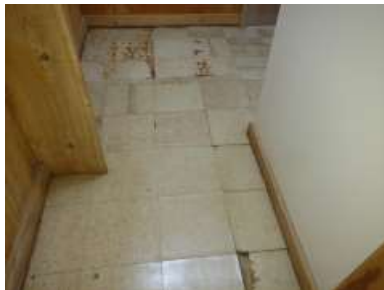
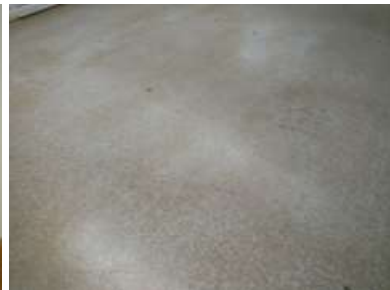
| <input type="checkbox"/> | <input checked="" type="checkbox"/> | <input type="checkbox"/> | Multiple types of floor coverings. Normal wear and tear noted throughout. |

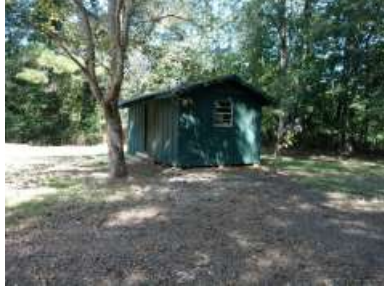
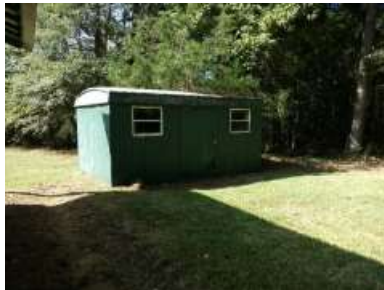
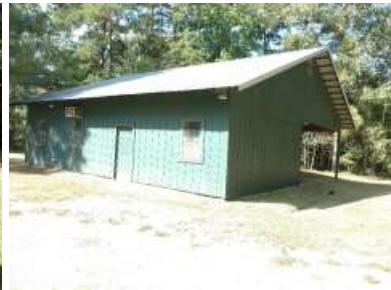
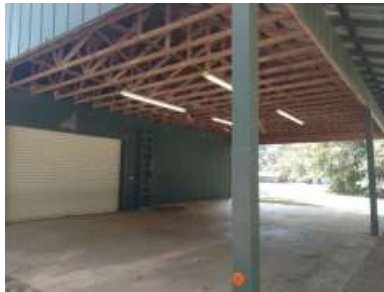
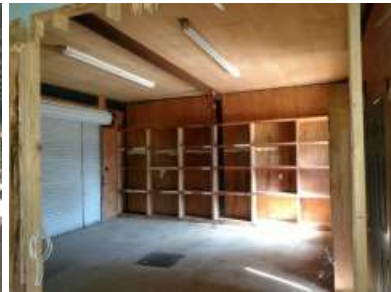
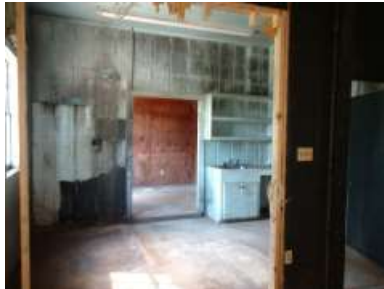
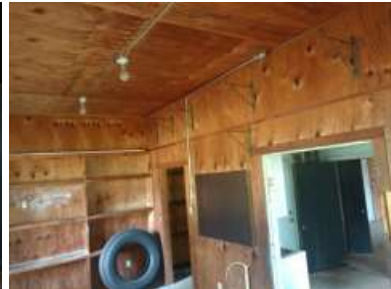
Out buildings and shop not part of this inspection. Pictures are for reference only.
