InspectionSmith 1614 Frances Place Monroe LA 71201 318-243-3912 inspectionsmithmonroe@gmail.com

Report: 2208 desiree, ruston 09-09-2019

Confidential Inspection Report 2208 Desiree Ruston, la

September 9, 2019

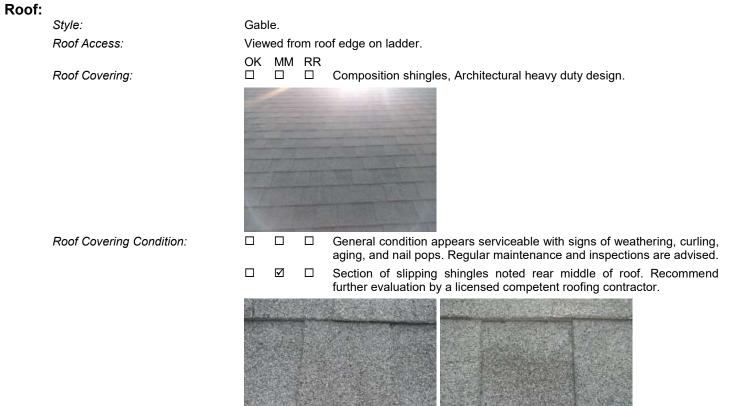
<u>Roof:</u> *Roof Covering Condition:* Section of slipping shingles noted rear middle of roof. Recommend further evaluation by a licensed competent roofing contractor.
