Report: 501 w. alabama ave, ruston 01-09-2020

Confidential Inspection Report

501 W. Alabama Ave

Ruston, la

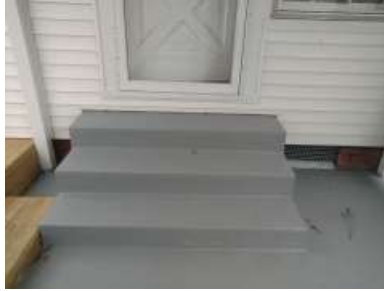
Exterior Steps / Stoops: Rear General condition appears serviceable. When steps have three or more risers, it is recommended that a hand rail be provided.

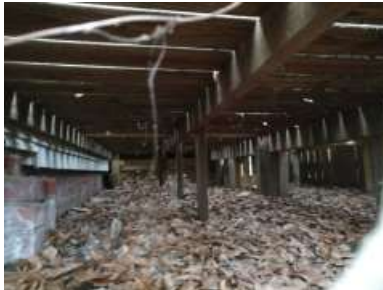
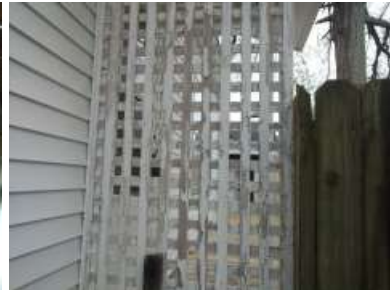
- OK MM RR
- Type: Wood posts.
- Chipping paint at lattice.

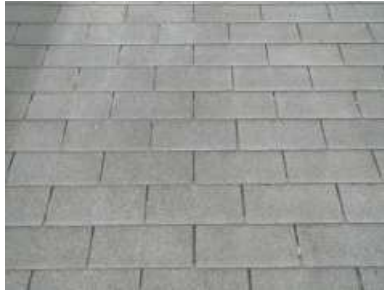
Roof Covering Condition:
 Recommend further evaluation by a licensed competent roofing contractor due to heavy wear and damaged shingles.
 heavy wear and tear noted.
 moss growth noted.
 Patch noted front side of house.
 Multiple patches noted left side of house.
 Damaged shingles rear patio. Decking visible, area of deterioration noted.
 Damaged shingles noted at garage.

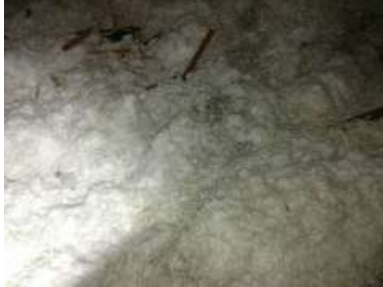
Insulation has been disturbed and good coverage is no longer present, Insulation is somewhat compacted and the true R-factor at this point in time may be substantially less than that originally installed. Installation of additional insulation is recommended. 3-8 inches.

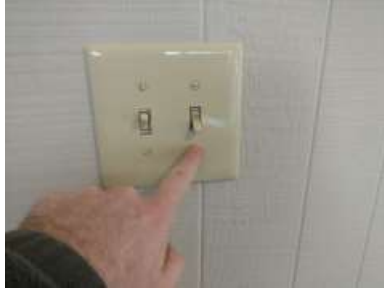
| | <input type="checkbox"/> | <input type="checkbox"/> | <input type="checkbox"/> | Right switch not identified. |

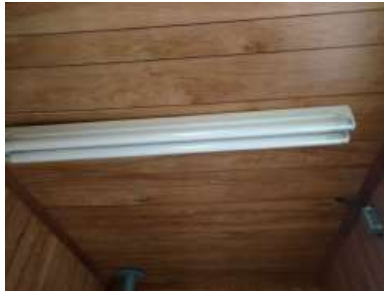
| <i>Laundry:</i> | <input type="checkbox"/> | <input type="checkbox"/> | <input type="checkbox"/> | Light out. |

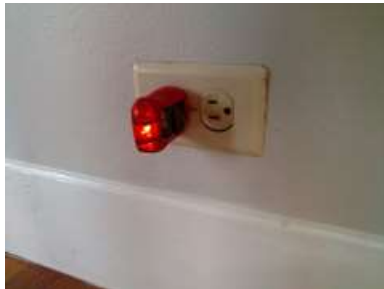
Bedroom #2: Rear

Reverse polarity is noted, Outlet by closet.

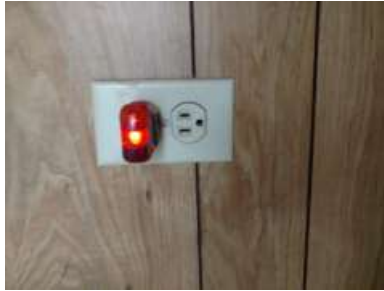
Some grounded type outlets did not appear to be properly grounded.
 220 unable to test.

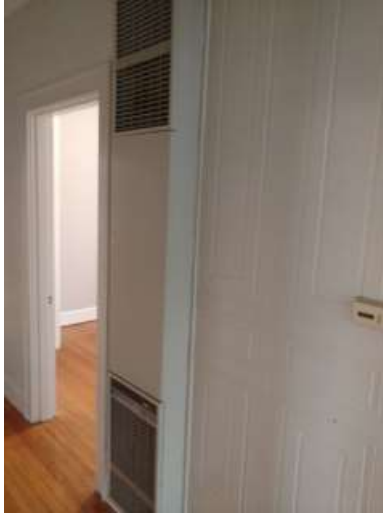
| | <input type="checkbox"/> | <input checked="" type="checkbox"/> | <input type="checkbox"/> | Wall heater in hall not tested. it was not determined if unit is functional. |

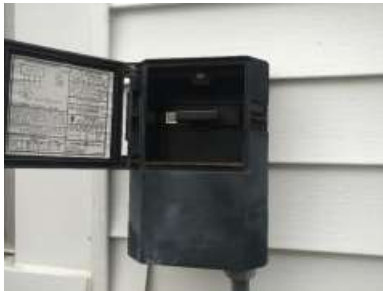
Fuel Source:

220 Volt, Electrical disconnect present.

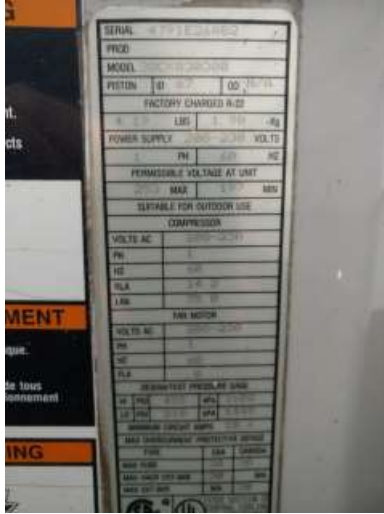
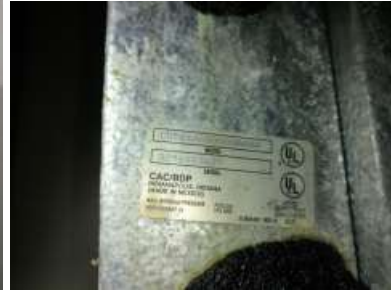
Approx. Age:
Appears to be 1991.

Air Temp Drop:
16 F Considered acceptable.

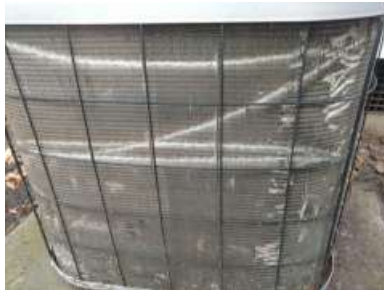
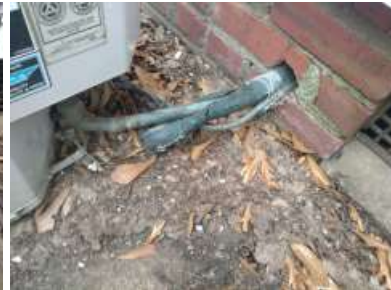
System Condition:

General condition appears serviceable. Older unit with wear and tear noted. Limit life expectancy.

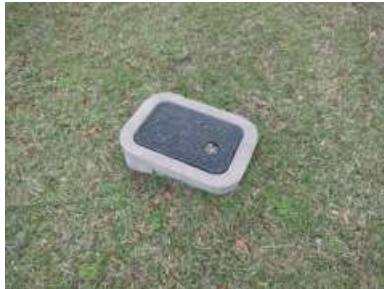
Shut Off:

Water meter is located, at the east side of the house.

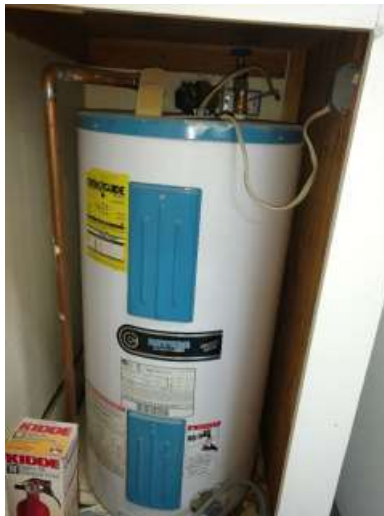
Condition:

Appears serviceable, Pressure relief valve noted, not tested, A water shutoff valve is installed. older unit limited life expectancy.

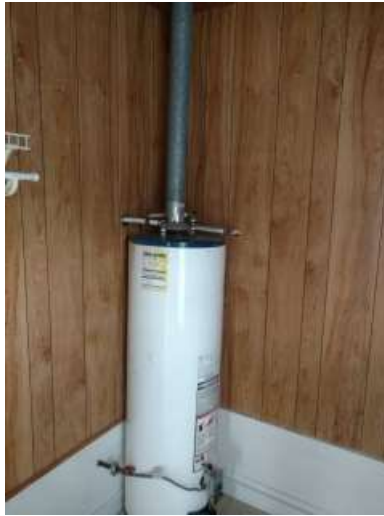
Condition:

Appears serviceable, Pressure relief valve noted, not tested, Flue vent intact, A water shutoff valve is installed. older unit limited life expectancy.

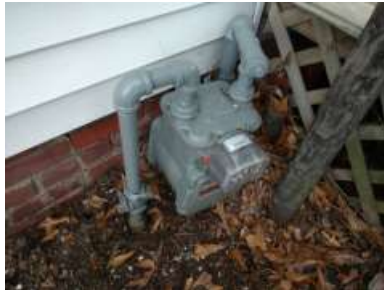
Meter / Tank:

Meter located at exterior, System appears serviceable, main shut off is located at meter. Right side of house.

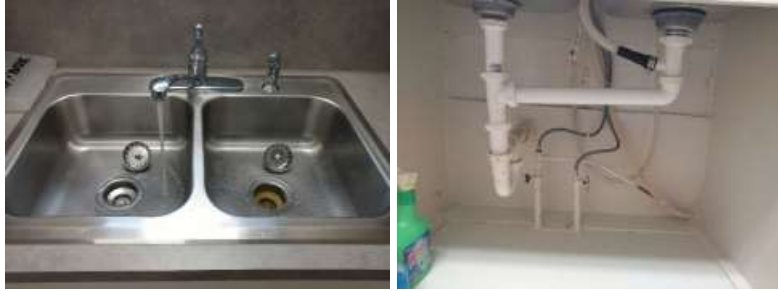
Kitchen Sink:

Stainless Steel, Faucet is serviceable, Hand sprayer is serviceable.
 under sink drain appears serviceable.

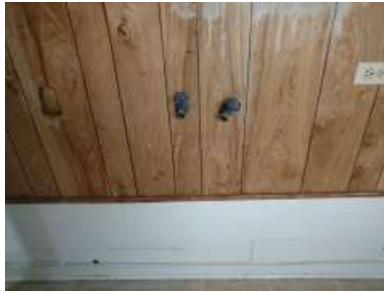
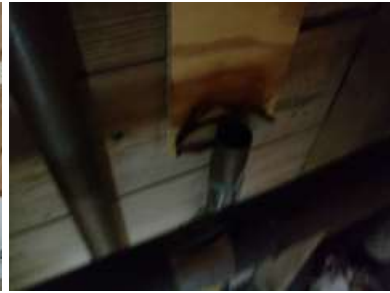
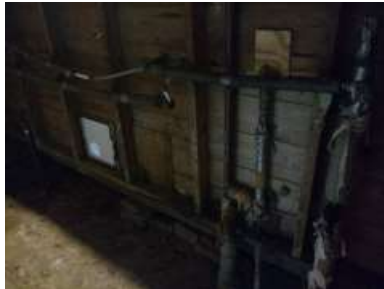
Laundry:

drain line is present , it is covered by a board. plumbing for laundry room not tested.

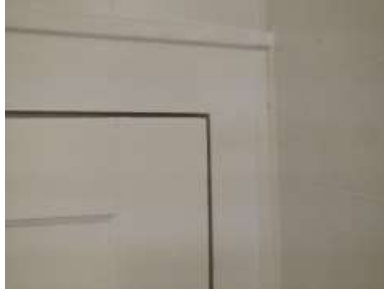
OK	MM	RR	
<i>Overall Interior Door Condition:</i>	<input checked="" type="checkbox"/>	<input type="checkbox"/>	<input type="checkbox"/>	General condition of doors throughout the home are in serviceable condition. Some doors may need some minor adjustments.
<i>Hall Bath:</i>	<input type="checkbox"/>	<input checked="" type="checkbox"/>	<input type="checkbox"/>	Door rubs frame, adjustments recommended.

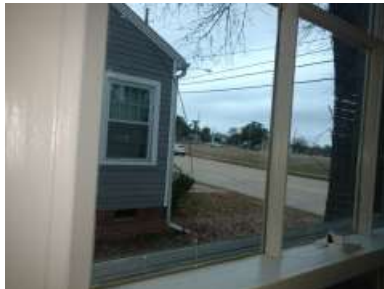
Dining Room:

Cracked window.

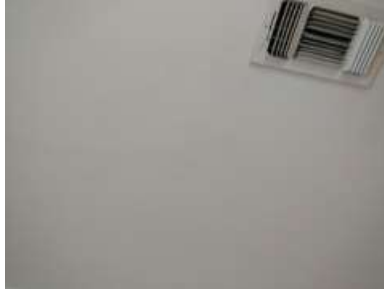
Dining Room: OK MM RR
 Bedroom #1: Side OK MM RR
 Bedroom #2: Rear OK MM RR There is some minor cracking noted. Be sure to take note of any future movement. Most minor cracking is due to shrinkage of the construction materials.

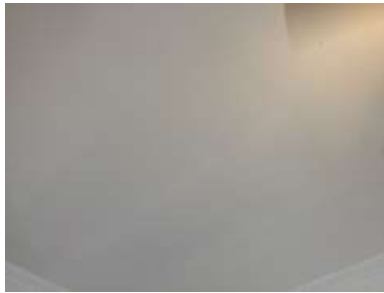
Sun Room:

There is some minor cracking noted. Be sure to take note of any future movement. Most minor cracking is due to shrinkage of the construction materials.

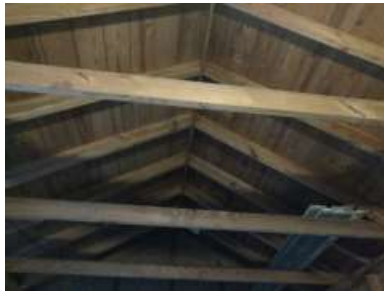
Ceilings:

Condition:

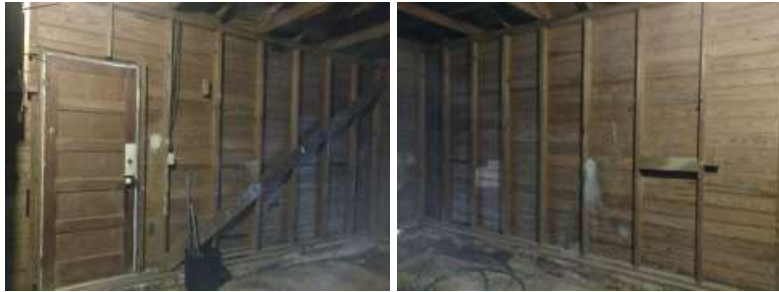
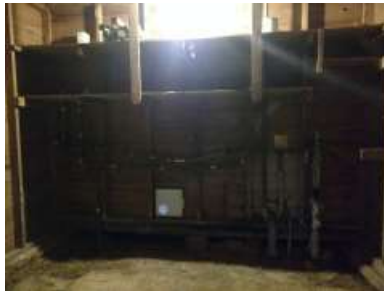
Garage Walls: Interior

OK MM RR
 General condition appears serviceable.

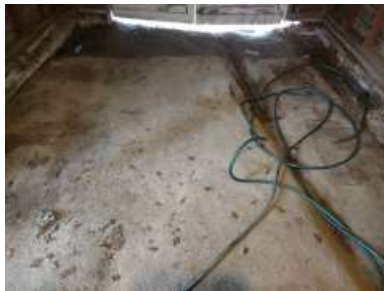
Floor:

Soil.
